SIEVE ANALYSIS: SINGER ISLAND.GPJ FL DEP ROSS.GDT 9/23/05

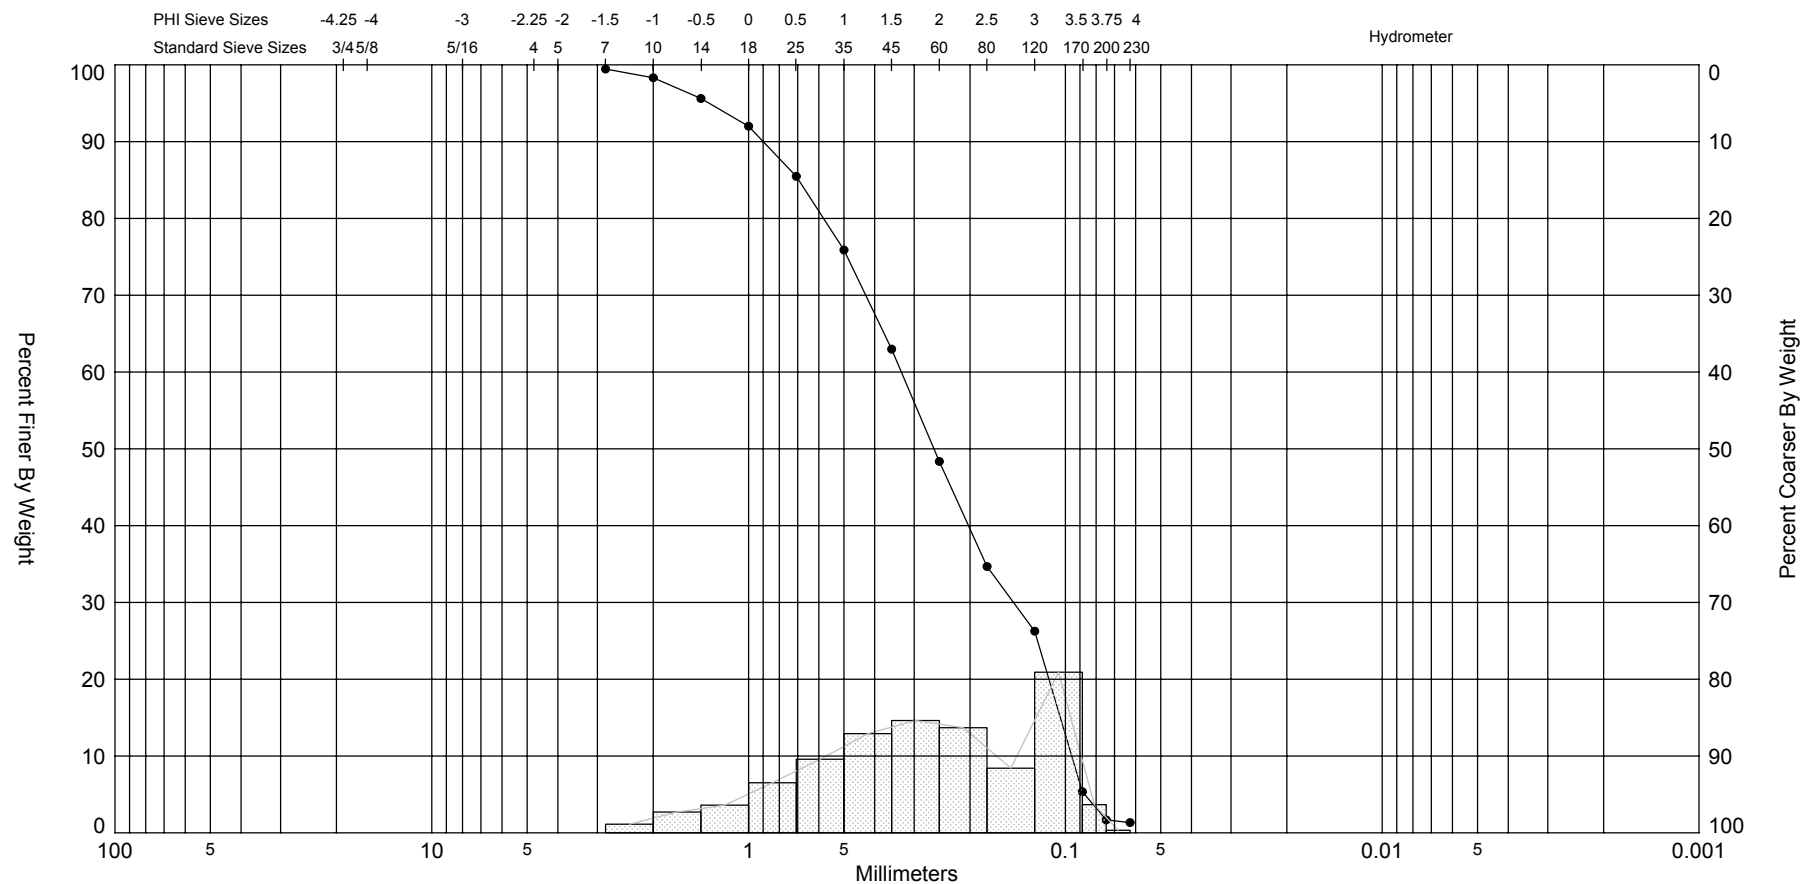
-67.4	SP	#200 - 1.68 #230 - 1.34		53.79	1.94	1.84	-0.39	2.39	1.2	Project Name:	Singer Island 2005
Comments:												Analysis Date:	08-18-05
Depths and elevations based on measured values												Analyzed By:	SEA Inc.
						Scientific Environmental Applications 5575 Willoughby Drive Melbourne, FL 32934 ph 321 254-2708 fax 321 254-2708						Easting (X, ft):	975,278
												Northing (Y, ft):	904,125
												Horizontal System:	NAD 1983
												Vertical System:	NGVD 29
