SIEVE ANALYSIS: SINGER ISLAND.GPJ FL DEP ROSS.GDT 9/23/05

Sample	Symbol	Elev. (ft)	USCS	% Fines	% Organics	% Carbonates	Median	Mean	Skew	Kurt	Sort	Sample Information	
SI-05-78 #1.0	—●—	-50.9	SP	#200 - 1.89 #230 - 0.91		19.39	3.14	3.08	-2.1	13.24	0.38	Project Name:	Singer Island 2005
Comments:												Analysis Date:	09-06-05
Depths and elevations based on measured values												Analyzed By:	SEA Inc.
						Scientific Environmental Applications 5575 Willoughby Drive Melbourne, FL 32934 ph 321 254-2708 fax 321 254-2708						Easting (X, ft):	974,123
												Northing (Y, ft):	904,661
												Horizontal System:	NAD 1983
												Vertical System:	NGVD 29

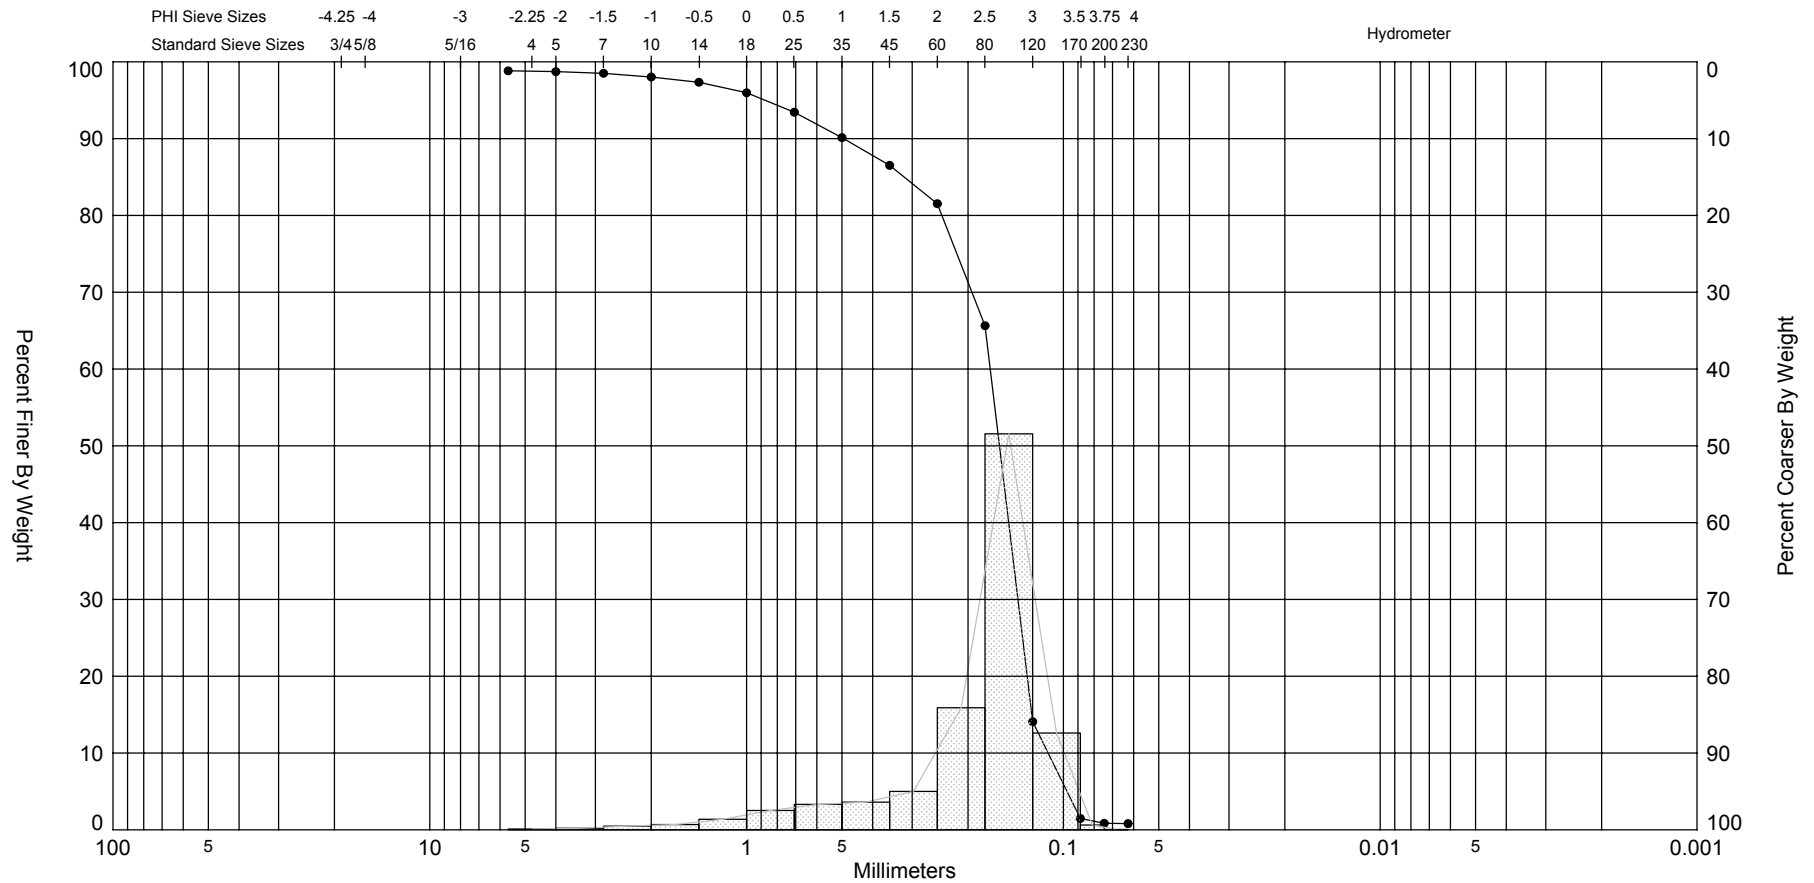
SIEVE ANALYSIS: SINGER ISLAND.GPJ FL DEP ROSS.GDT 9/23/05

Sample	Symbol	Elev. (ft)	USCS	% Fines	% Organics	% Carbonates	Median	Mean	Skew	Kurt	Sort	Sample Information	
SI-05-78 #5.0	—●—	-54.9	SP	#200 - 0.85 #230 - 0.81		45.89	2.65	2.34	-1.87	7.29	0.86	Project Name:	Singer Island 2005
Comments:												Analysis Date:	09-06-05
Depths and elevations based on measured values												Analyzed By:	SEA Inc.
						Scientific Environmental Applications 5575 Willoughby Drive Melbourne, FL 32934 ph 321 254-2708 fax 321 254-2708						Easting (X, ft):	974,123
												Northing (Y, ft):	904,661
												Horizontal System:	NAD 1983
												Vertical System:	NGVD 29

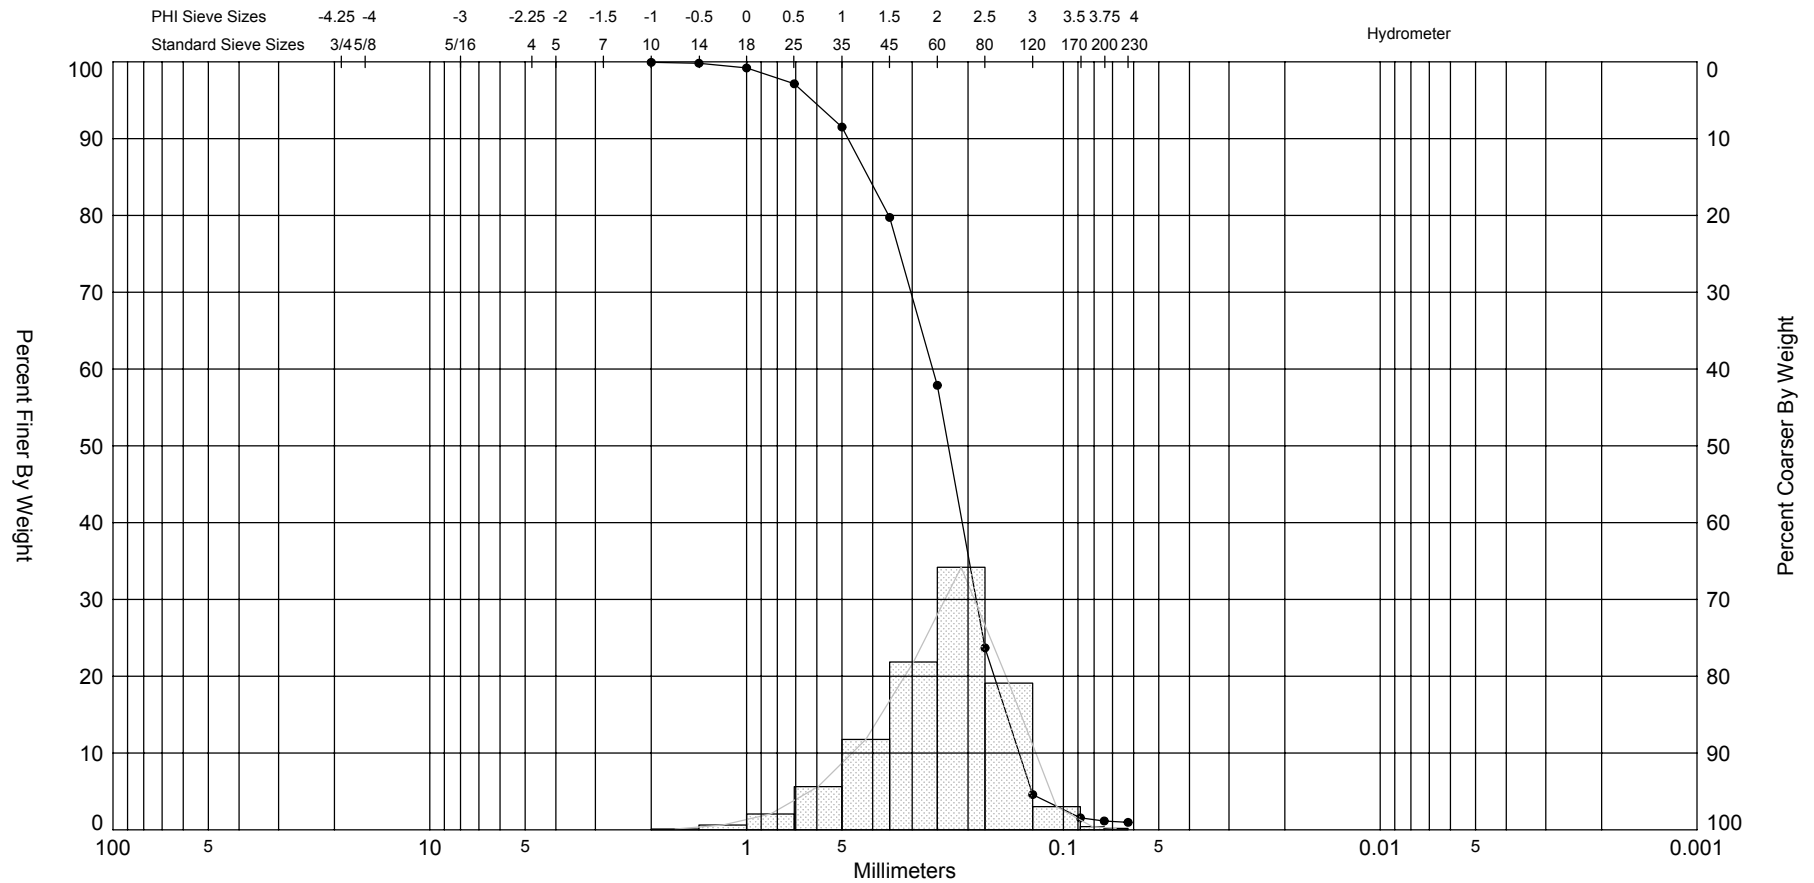
SIEVE ANALYSIS: SINGER ISLAND.GPJ FL DEP ROSS.GDT 9/23/05

Sample	Symbol	Elev. (ft)	USCS	% Fines	% Organics	% Carbonates	Median	Mean	Skew	Kurt	Sort	Sample Information	
SI-05-78 #10.0	—●—	-59.9	SP	#200 - 1.15 #230 - 0.97		67.03	2.12	2.01	-0.64	3.61	0.68	Project Name:	Singer Island 2005
Comments:												Analysis Date:	09-06-05
Depths and elevations based on measured values												Analyzed By:	SEA Inc.
						Scientific Environmental Applications 5575 Willoughby Drive Melbourne, FL 32934 ph 321 254-2708 fax 321 254-2708						Easting (X, ft):	974,123
												Northing (Y, ft):	904,661
												Horizontal System:	NAD 1983
												Vertical System:	NGVD 29

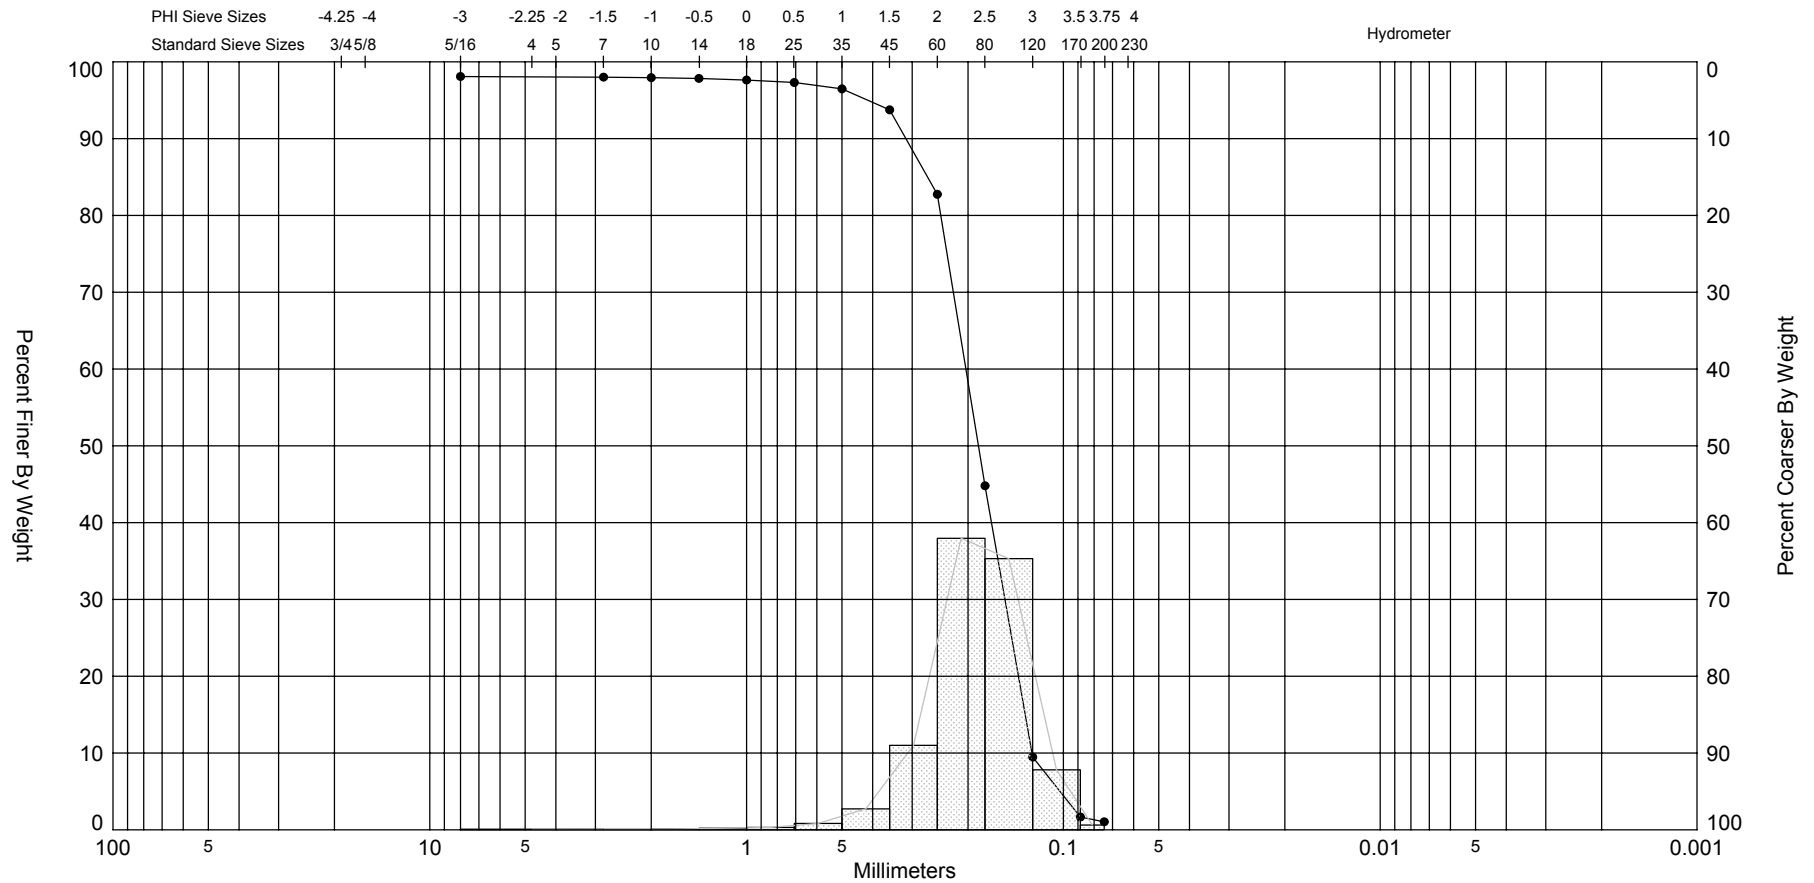
SIEVE ANALYSIS: SINGER ISLAND.GPJ FL DEP ROSS.GDT 9/23/05

Sample	Symbol	Elev. (ft)	USCS	% Fines	% Organics	% Carbonates	Median	Mean	Skew	Kurt	Sort	Sample Information	
SI-05-78 #15.0	—●—	-64.9	SP	#200 - 1.05		62.46	2.43	2.28	-0.89	9.29	0.55	Project Name:	Singer Island 2005
Comments:												Analysis Date:	09-06-05
Depths and elevations based on measured values												Analyzed By:	SEA Inc.
						Scientific Environmental Applications 5575 Willoughby Drive Melbourne, FL 32934 ph 321 254-2708 fax 321 254-2708						Easting (X, ft):	974,123
												Northing (Y, ft):	904,661
												Horizontal System:	NAD 1983
												Vertical System:	NGVD 29

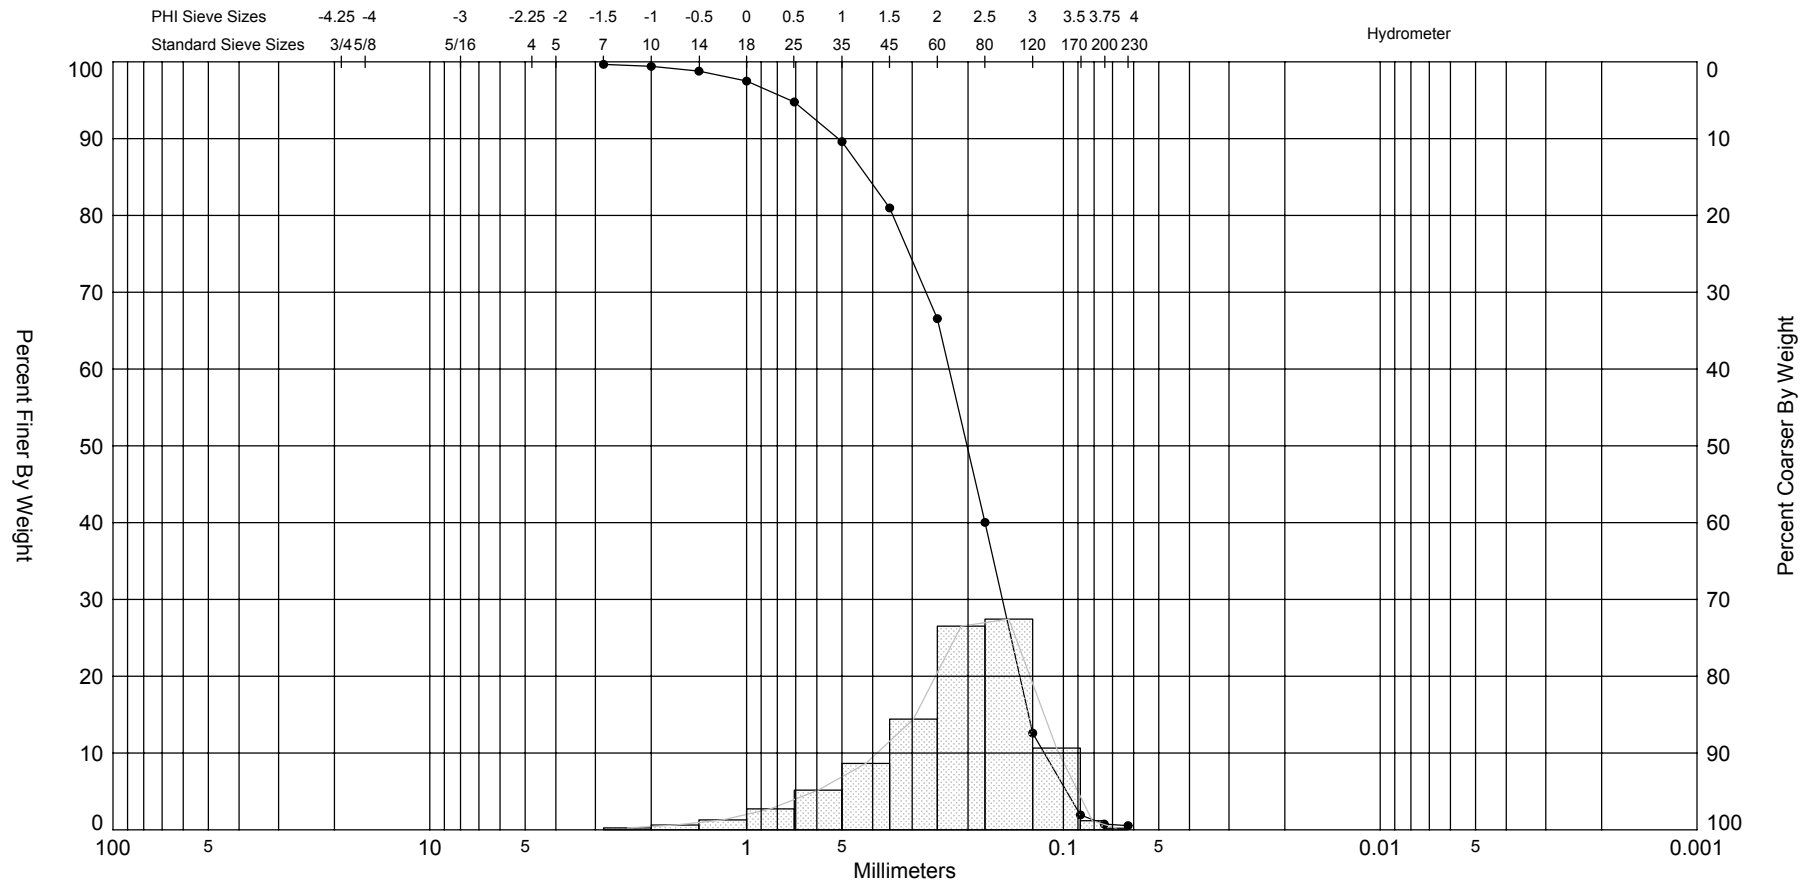
SIEVE ANALYSIS: SINGER ISLAND.GPJ FL DEP ROSS.GDT 9/23/05

Sample	Symbol	Elev. (ft)	USCS	% Fines	% Organics	% Carbonates	Median	Mean	Skew	Kurt	Sort	Sample Information	
SI-05-78 #Comp	—●—	-66.9	SP	#200 - 0.75 #230 - 0.55		60.25	2.31	2.15	-0.97	4.11	0.85	Project Name:	Singer Island 2005
Comments:												Analysis Date:	09-06-05
Depths and elevations based on measured values												Analyzed By:	SEA Inc.
						Scientific Environmental Applications						Easting (X, ft):	974,123
						5575 Willoughby Drive						Northing (Y, ft):	904,661
						Melbourne, FL 32934						Horizontal System:	NAD 1983
						ph 321 254-2708						Vertical System:	NGVD 29
						fax 321 254-2708
