SIEVE ANALYSIS: SINGER ISLAND.GPJ FL DEP ROSS.GDT 9/23/05

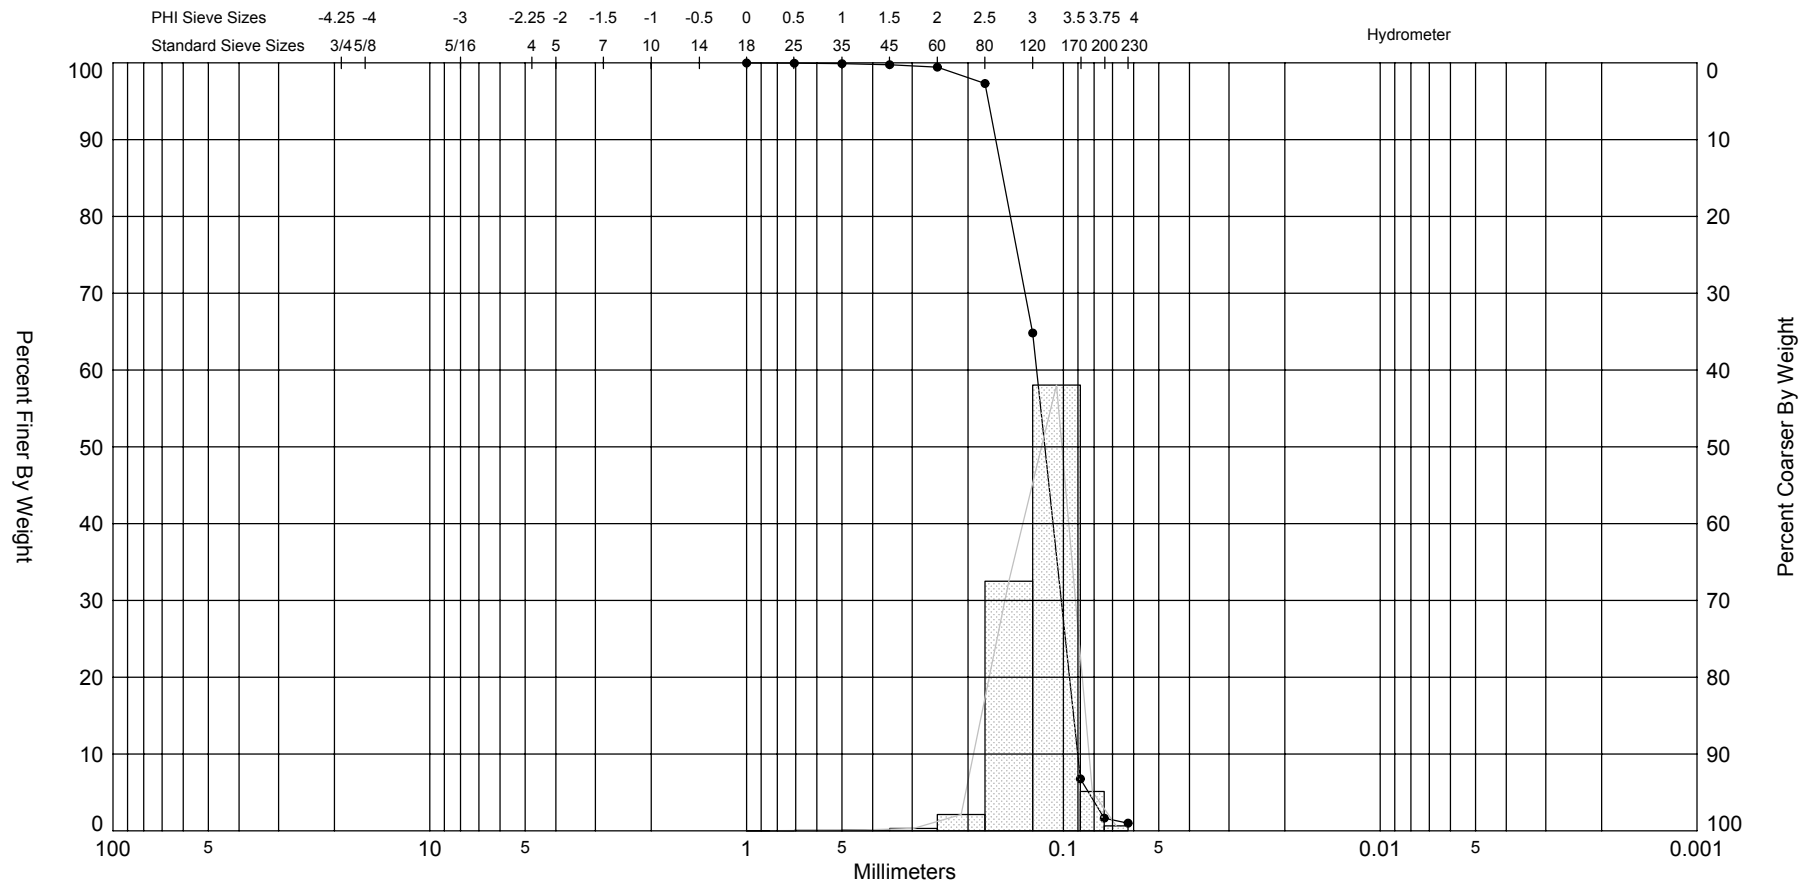
Gravel		Sand			Silt and Clay	
Coarse	Fine	Coarse	Medium	Fine

Sample	Symbol	Elev. (ft)	USCS	% Fines	% Organics	% Carbonates	Median	Mean	Skew	Kurt	Sort	Sample Information	
SI-05-77 #1.0	—●—	-44.8	SP	#200 - 1.65 #230 - 1.00		18.35	3.13	3.08	-1.17	7.77	0.32	Project Name:	Singer Island 2005
Comments:												Analysis Date:	09-03-05
Depths and elevations based on measured values												Analyzed By:	SEA Inc.
						Scientific Environmental Applications 5575 Willoughby Drive Melbourne, FL 32934 ph 321 254-2708 fax 321 254-2708						Easting (X, ft):	973,688
												Northing (Y, ft):	905,367
												Horizontal System:	NAD 1983
												Vertical System:	NGVD 29

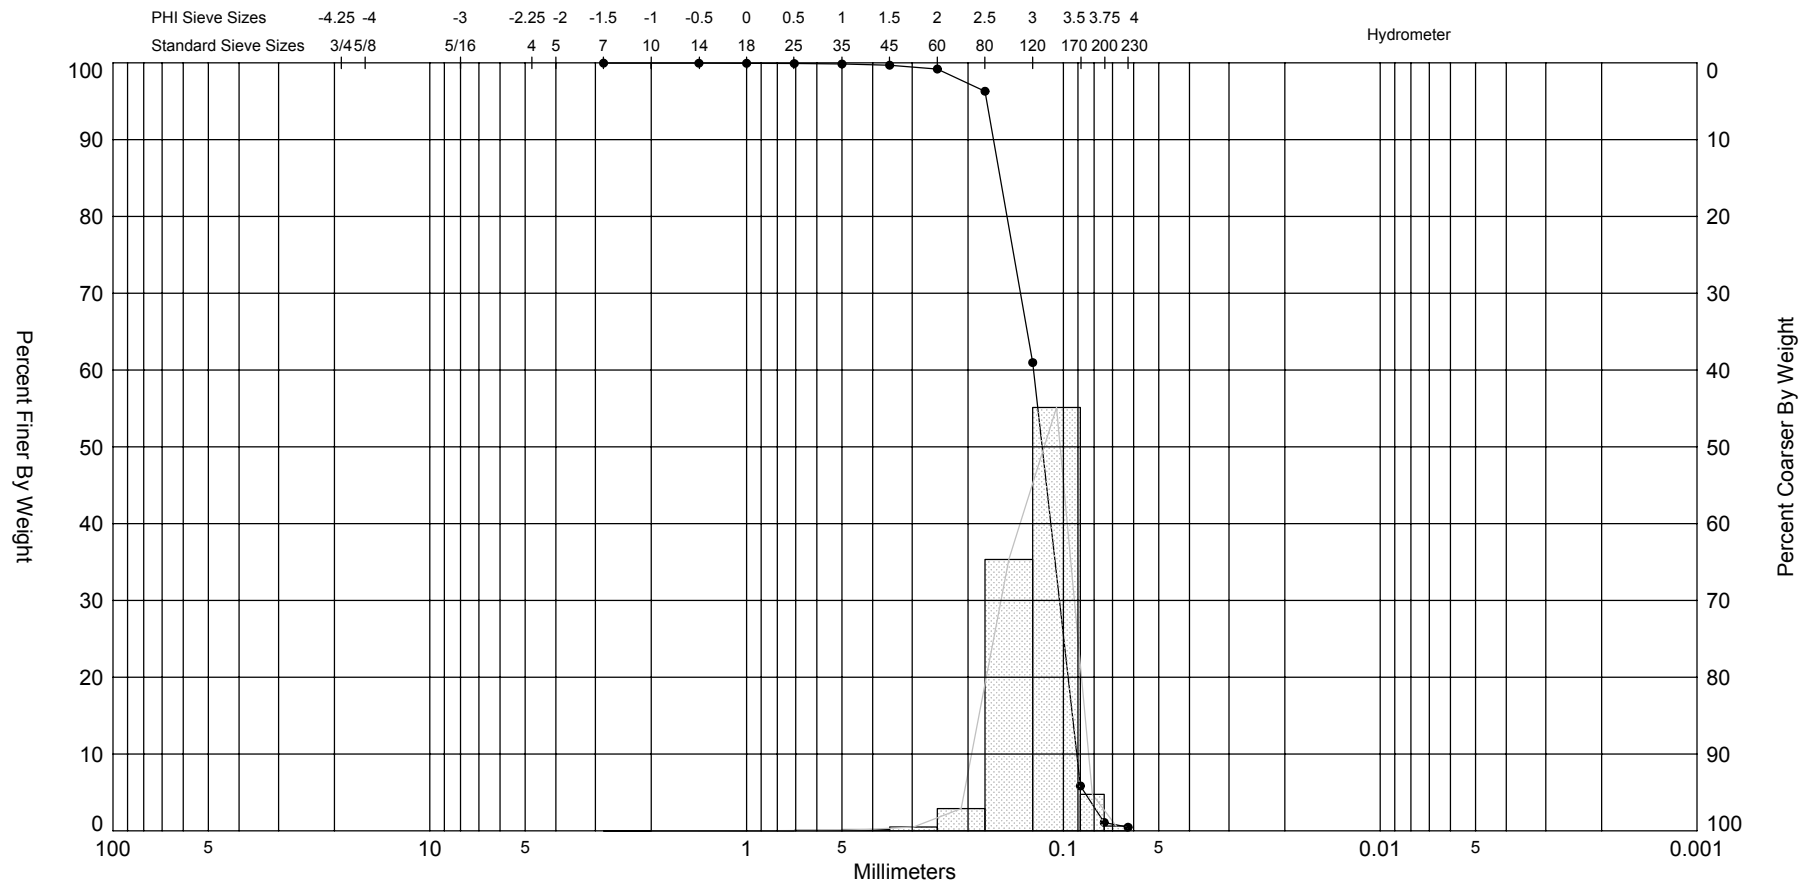
SIEVE ANALYSIS: SINGER ISLAND.GPJ FL DEP ROSS.GDT 9/23/05

Gravel		Sand			Silt and Clay	
Coarse	Fine	Coarse	Medium	Fine

Sample	Symbol	Elev. (ft)	USCS	% Fines	% Organics	% Carbonates	Median	Mean	Skew	Kurt	Sort	Sample Information	
SI-05-77 #3.0	—●—	-46.8	SP	#200 - 1.09 #230 - 0.47		19.43	3.1	3.05	-1.35	10.1	0.34	Project Name:	Singer Island 2005
Comments:												Analysis Date:	09-03-05
Depths and elevations based on measured values												Analyzed By:	SEA Inc.
						Scientific Environmental Applications 5575 Willoughby Drive Melbourne, FL 32934 ph 321 254-2708 fax 321 254-2708						Easting (X, ft):	973,688
												Northing (Y, ft):	905,367
												Horizontal System:	NAD 1983
												Vertical System:	NGVD 29

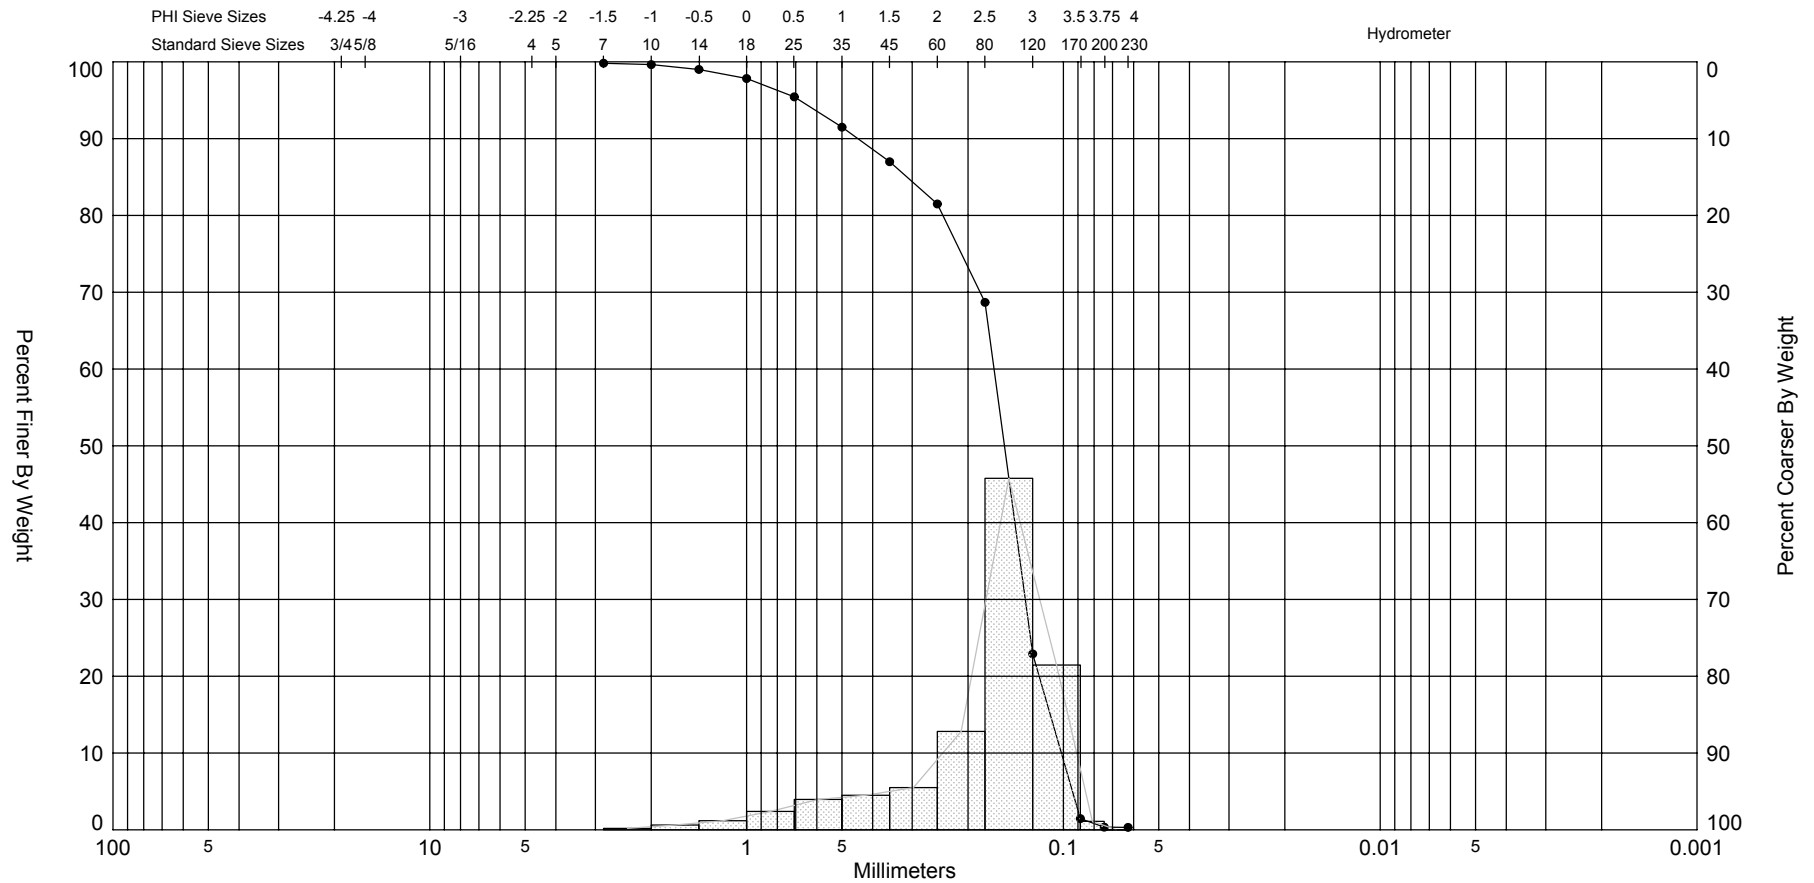
SIEVE ANALYSIS: SINGER ISLAND.GPJ FL DEP ROSS.GDT 9/23/05

Sample	Symbol	Elev. (ft)	USCS	% Fines	% Organics	% Carbonates	Median	Mean	Skew	Kurt	Sort	Sample Information	
SI-05-77 #6.0	—●—	-49.8	SP	#200 - 0.35 #230 - 0.32		38.01	2.7	2.47	-1.68	5.79	0.84	Project Name:	Singer Island 2005
Comments:												Analysis Date:	09-06-05
Depths and elevations based on measured values												Analyzed By:	SEA Inc.
						Scientific Environmental Applications 5575 Willoughby Drive Melbourne, FL 32934 ph 321 254-2708 fax 321 254-2708						Easting (X, ft):	973,688
												Northing (Y, ft):	905,367
												Horizontal System:	NAD 1983
												Vertical System:	NGVD 29

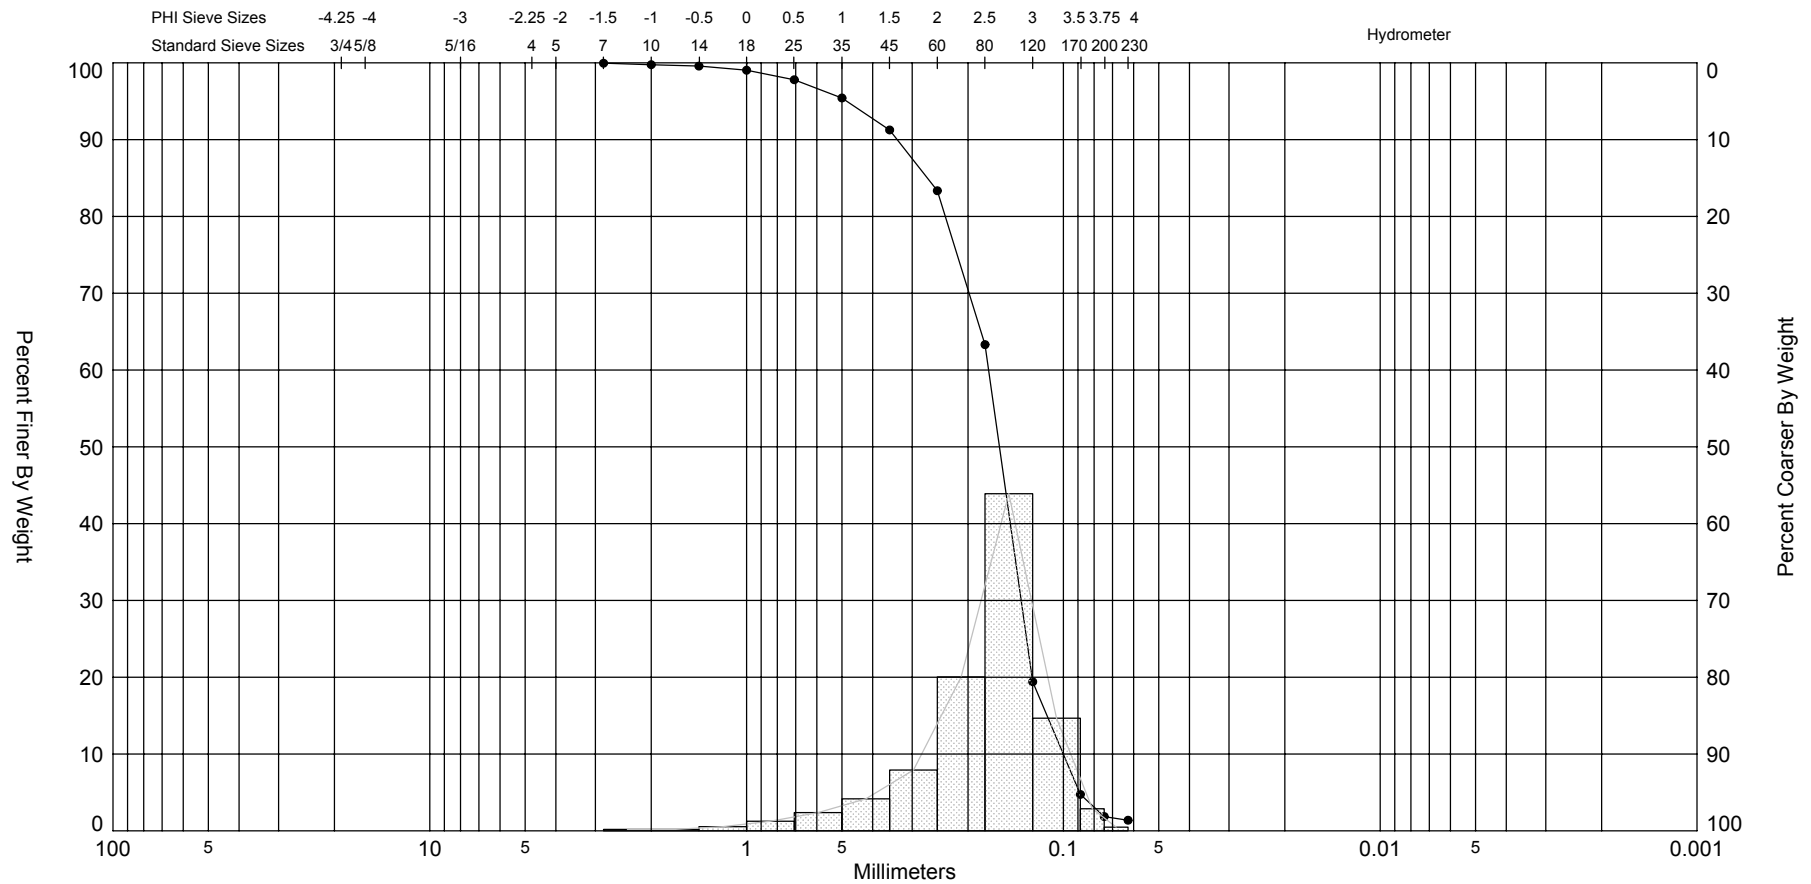
SIEVE ANALYSIS: SINGER ISLAND.GPJ FL DEP ROSS.GDT 9/23/05

Gravel		Sand			Silt and Clay	
Coarse	Fine	Coarse	Medium	Fine

Sample	Symbol	Elev. (ft)	USCS	% Fines	% Organics	% Carbonates	Median	Mean	Skew	Kurt	Sort	Sample Information	
SI-05-77 #9.0	—●—	-52.8	SP	#200 - 1.86 #230 - 1.38		43.41	2.65	2.5	-1.5	6.54	0.71	Project Name:	Singer Island 2005
Comments:												Analysis Date:	09-06-05
Depths and elevations based on measured values												Analyzed By:	SEA Inc.
						Scientific Environmental Applications 5575 Willoughby Drive Melbourne, FL 32934 ph 321 254-2708 fax 321 254-2708						Easting (X, ft):	973,688
												Northing (Y, ft):	905,367
												Horizontal System:	NAD 1983
												Vertical System:	NGVD 29

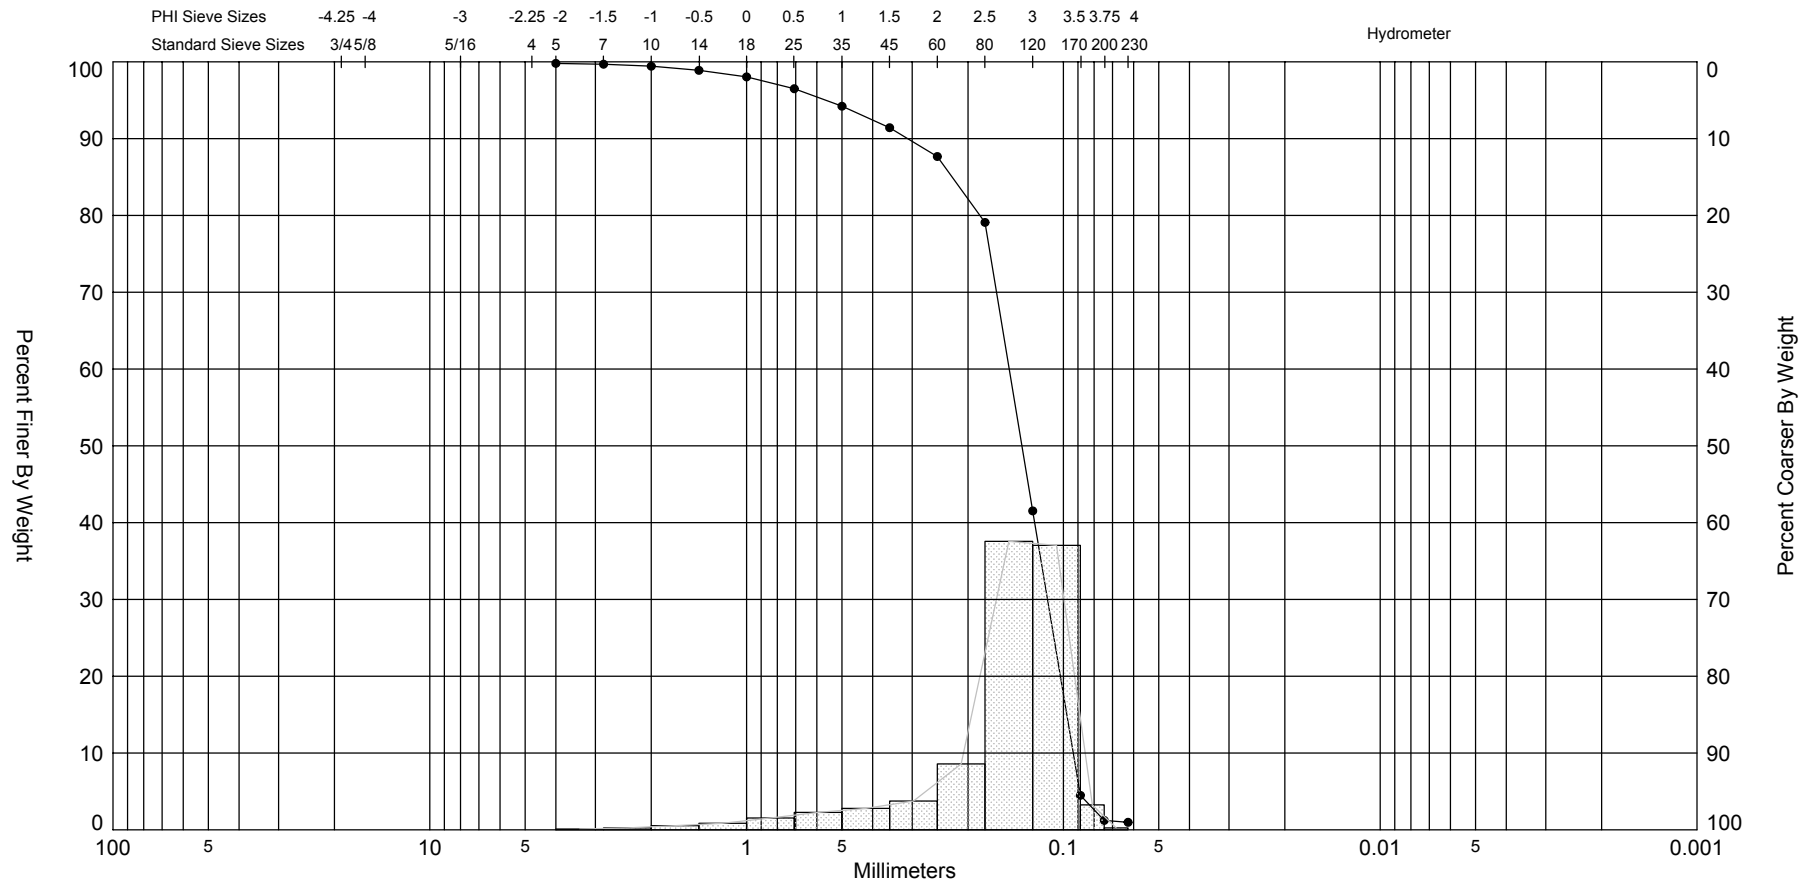
SIEVE ANALYSIS: SINGER ISLAND.GPJ FL DEP ROSS.GDT 9/23/05

Gravel		Sand			Silt and Clay	
Coarse	Fine	Coarse	Medium	Fine

Sample	Symbol	Elev. (ft)	USCS	% Fines	% Organics	% Carbonates	Median	Mean	Skew	Kurt	Sort	Sample Information	
SI-05-77 #Comp	—●—	-53.8	SP	#200 - 1.23 #230 - 0.98		33.01	2.89	2.69	-2.18	8.7	0.8	Project Name:	Singer Island 2005
Comments:												Analysis Date:	09-06-05
Depths and elevations based on measured values												Analyzed By:	SEA Inc.
						Scientific Environmental Applications 5575 Willoughby Drive Melbourne, FL 32934 ph 321 254-2708 fax 321 254-2708						Easting (X, ft):	973,688
												Northing (Y, ft):	905,367
												Horizontal System:	NAD 1983
												Vertical System:	NGVD 29
