SIEVE ANALYSIS JUPITER ISLAND 10.GPJ FL DEP ROSS.GDT 6/26/10

American Vibracore Services, Inc.		
											1215 Wallace Drive		
											Delray Beach, FL 33444		
											Easting (X, ft):		
											968035.		
											Northing (Y, ft):		
											975002.		
											Horizontal System:		
											NAD 1983		
											Vertical System:		
											NAVD 88

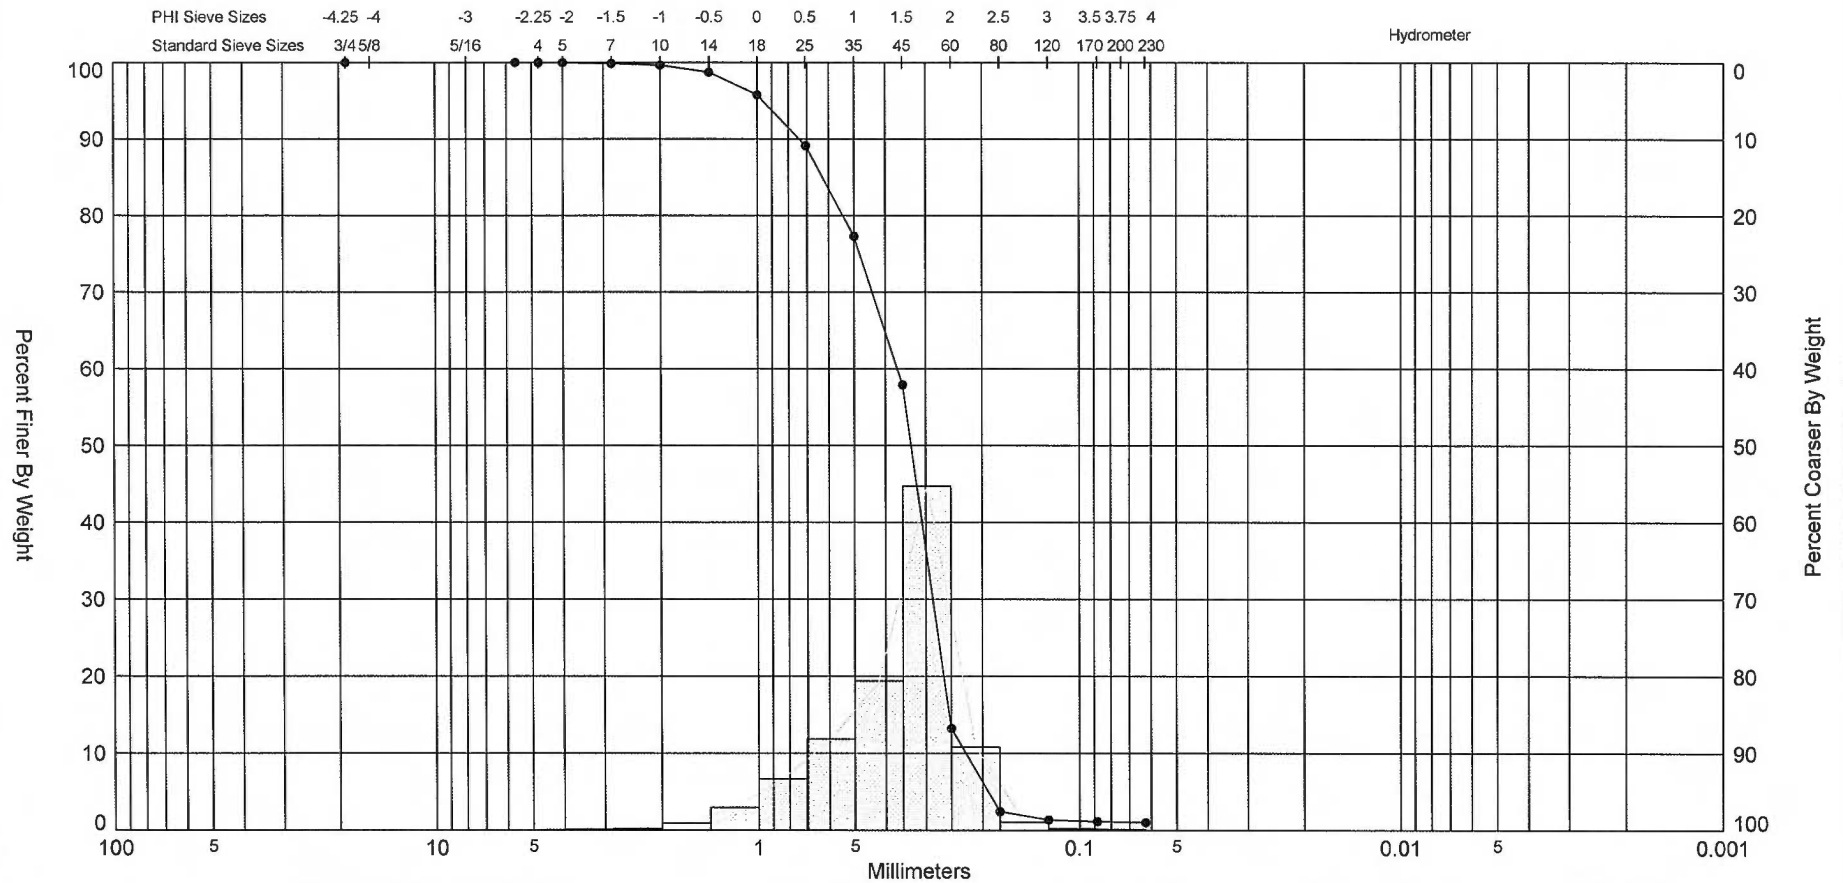
Gravel		Sand			Silt and Clay
Coarse	Fine	Coarse	Medium	Fine

Sample	Symbol	Elev. (ft)	USCS	% Fines	% Organics	% Carbonates	Median	Mean	Skew	Kurt	Sort	Sample Information	
JI-16 #S-1 (1.0')	—●—	-42.3	SP	#230 - 1.00			1.59	1.41	-1.01	4.65	0.68	Project Name:	Jupiter Island 10
Comments: 10 YR 5/1 Munsell @ 10% Moisture												Analysis Date:	04-21-10
Depths and elevations based on measured values												Analyzed By:	ML

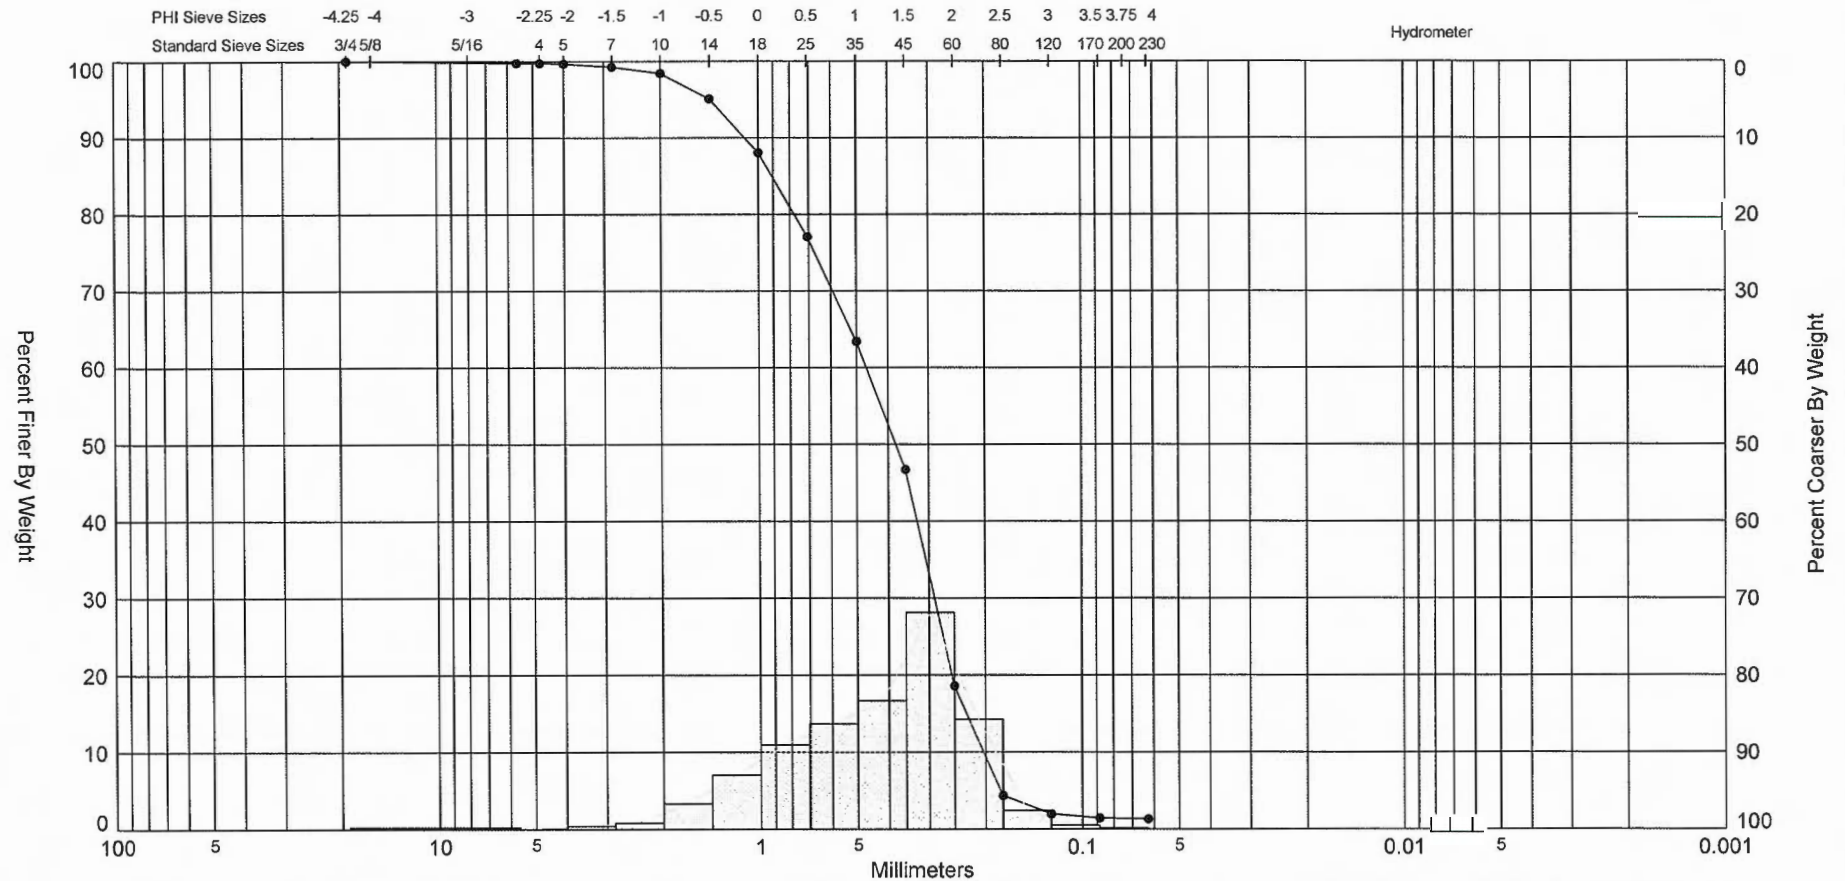
Gravel		Sand			Silt and Clay
Coarse	Fine	Coarse	Medium	Fine

Sample	Symbol	Elev. (ft)	USCS	% Fines	% Organics	% Carbonates	Median	Mean	Skew	Kurt	Sort	Sample Information	
JI-16 #S-2 (5.0')

-46.3	SW	#230 - 1.29		73.50	1.4	1.18	-0.78	3.94	0.94	Project Name:	Jupiter Island 10
Comments: 10 YR 5/1 Munsell @ 10% Moisture												Analysis Date:	04-24-10
Depths and elevations based on measured values												Analyzed By:	JR

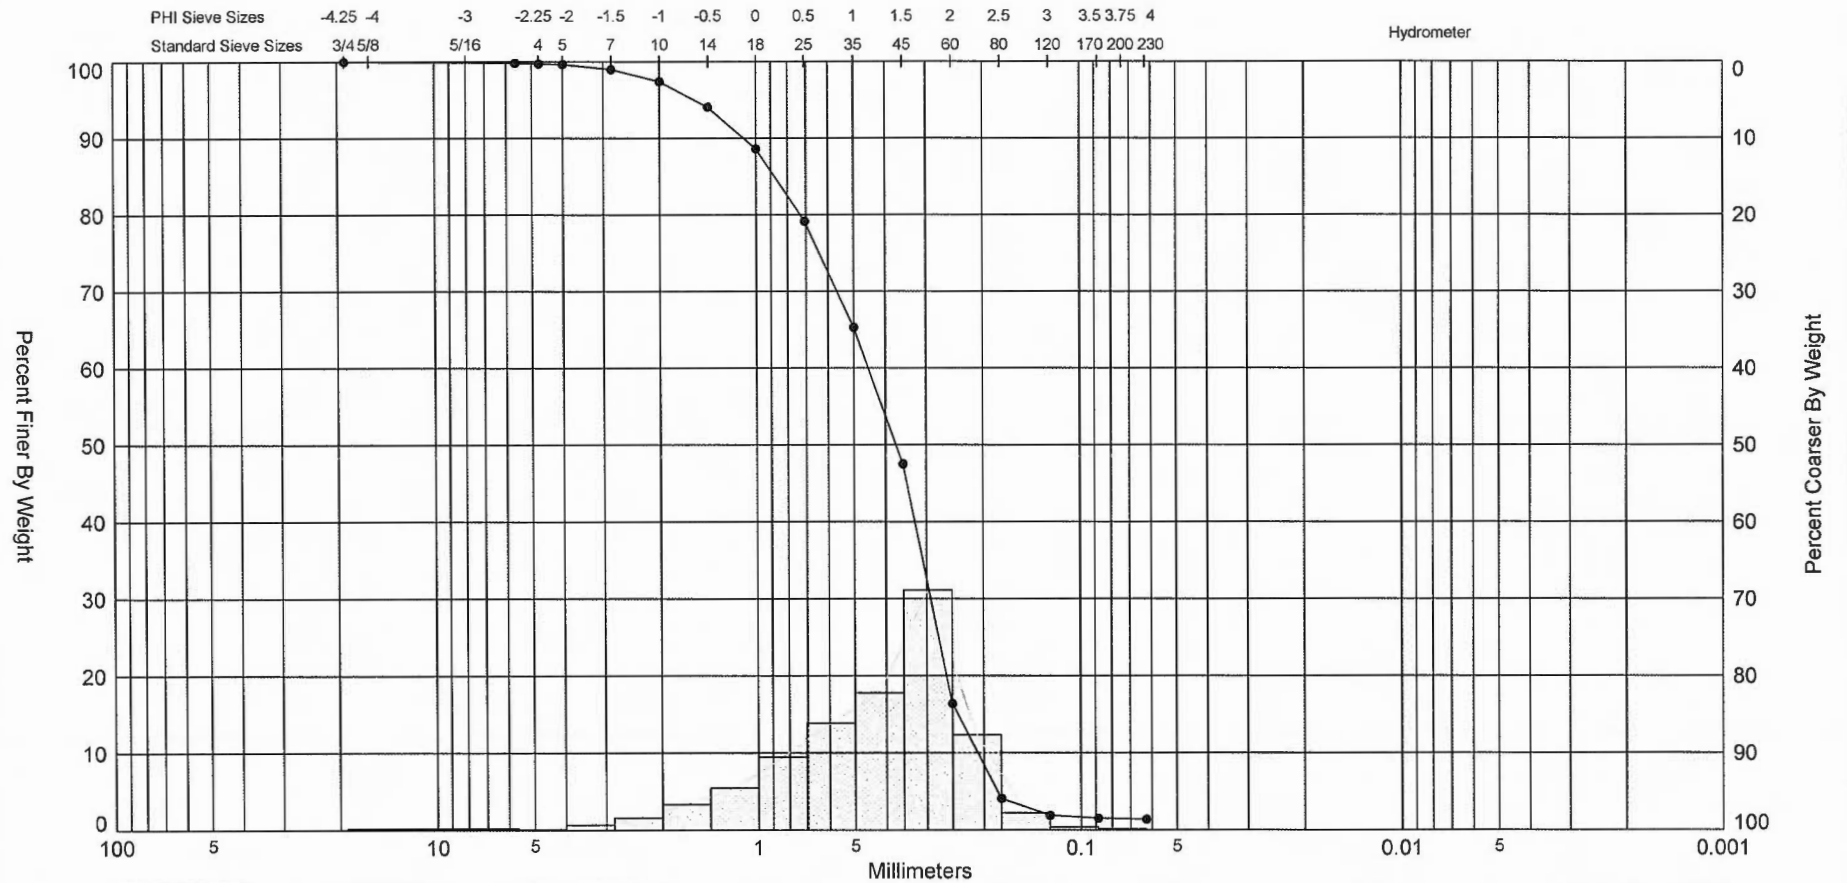
Gravel		Sand			Silt and Clay
Coarse	Fine	Coarse	Medium	Fine

Sample	Symbol	Elev. (ft)	USCS	% Fines	% Organics	% Carbonates	Median	Mean	Skew	Kurt	Sort	Sample Information	
JL-16 #S-3 (8.0')	—●—	-49.3	SW	#230 - 1.37			1.43	1.18	-0.96	4.27	0.94	Project Name:	Jupiter Island 10
Comments: 10 YR 5/1 Munsell @ 10% Moisture												Analysis Date:	04-21-10
Depths and elevations based on measured values												Analyzed By:	JR

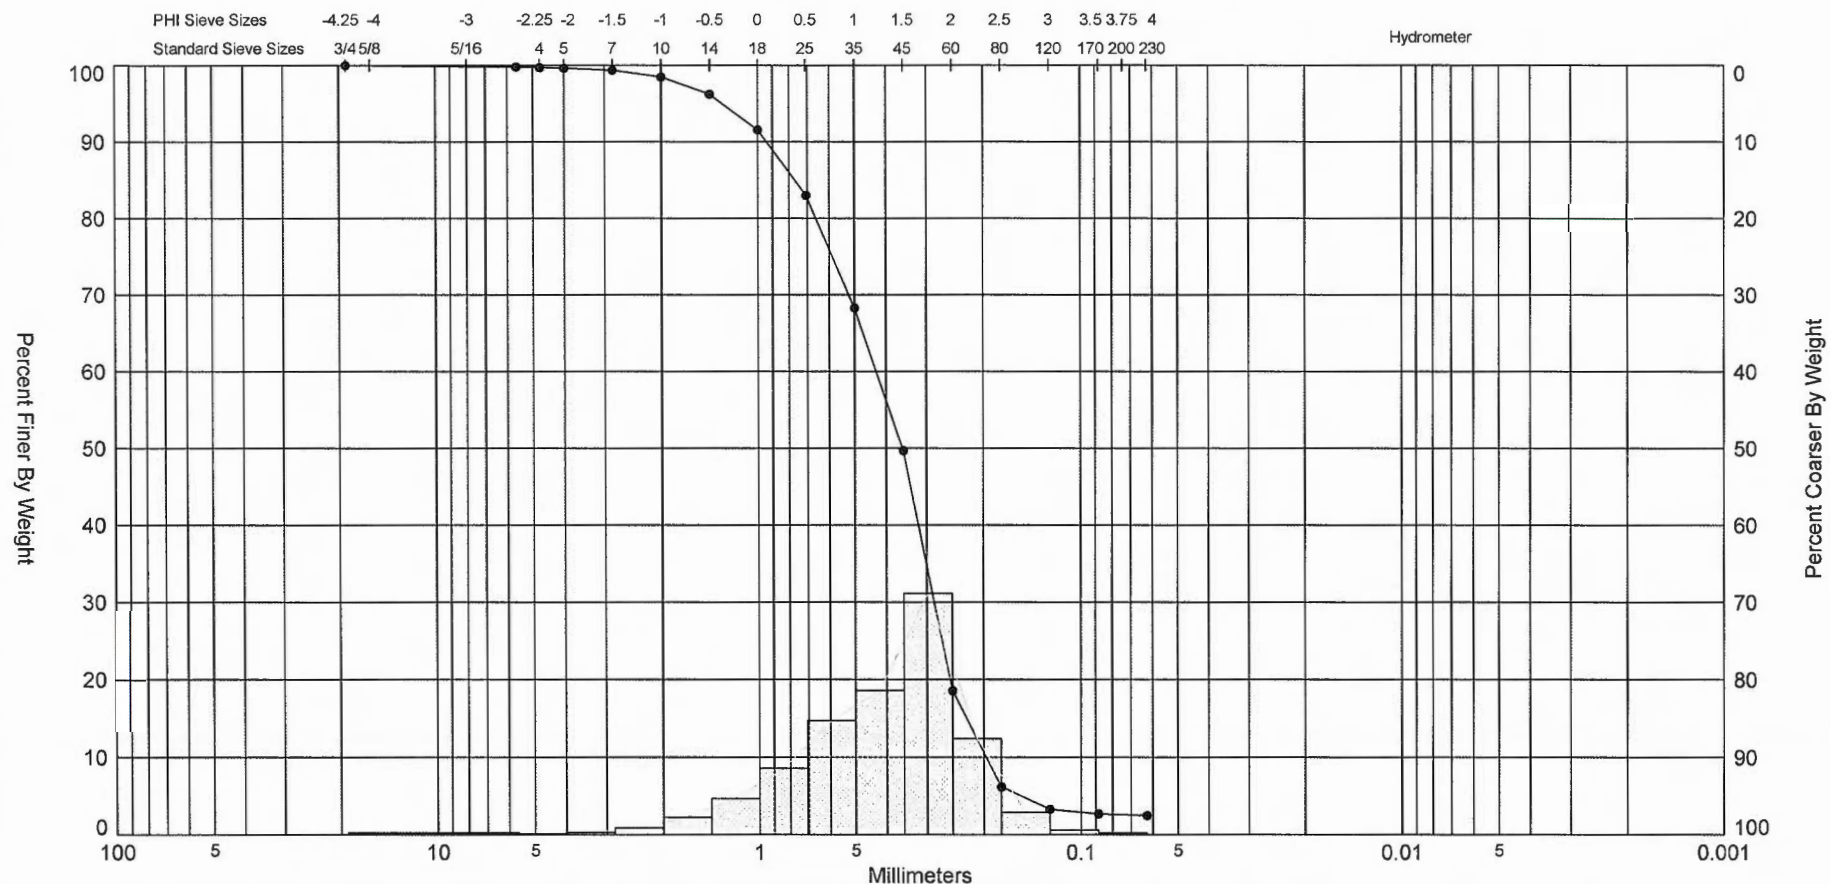
Gravel		Sand			Silt and Clay
Coarse	Fine	Coarse	Medium	Fine

Sample	Symbol	Elev. (ft)	USCS	% Fines	% Organics	% Carbonates	Median	Mean	Skew	Kurt	Sort	Sample Information	
JL-16 #S-4 (11.0')	—●—	-52.3	SW	#230 - 2.46		67.60	1.49	1.27	-0.95	5.03	0.89	Project Name:	Jupiter Island 10
Comments: 10 YR 4/1 Munsell @ 10% Moisture												Analysis Date:	04-16-10
Depths and elevations based on measured values												Analyzed By:	ML

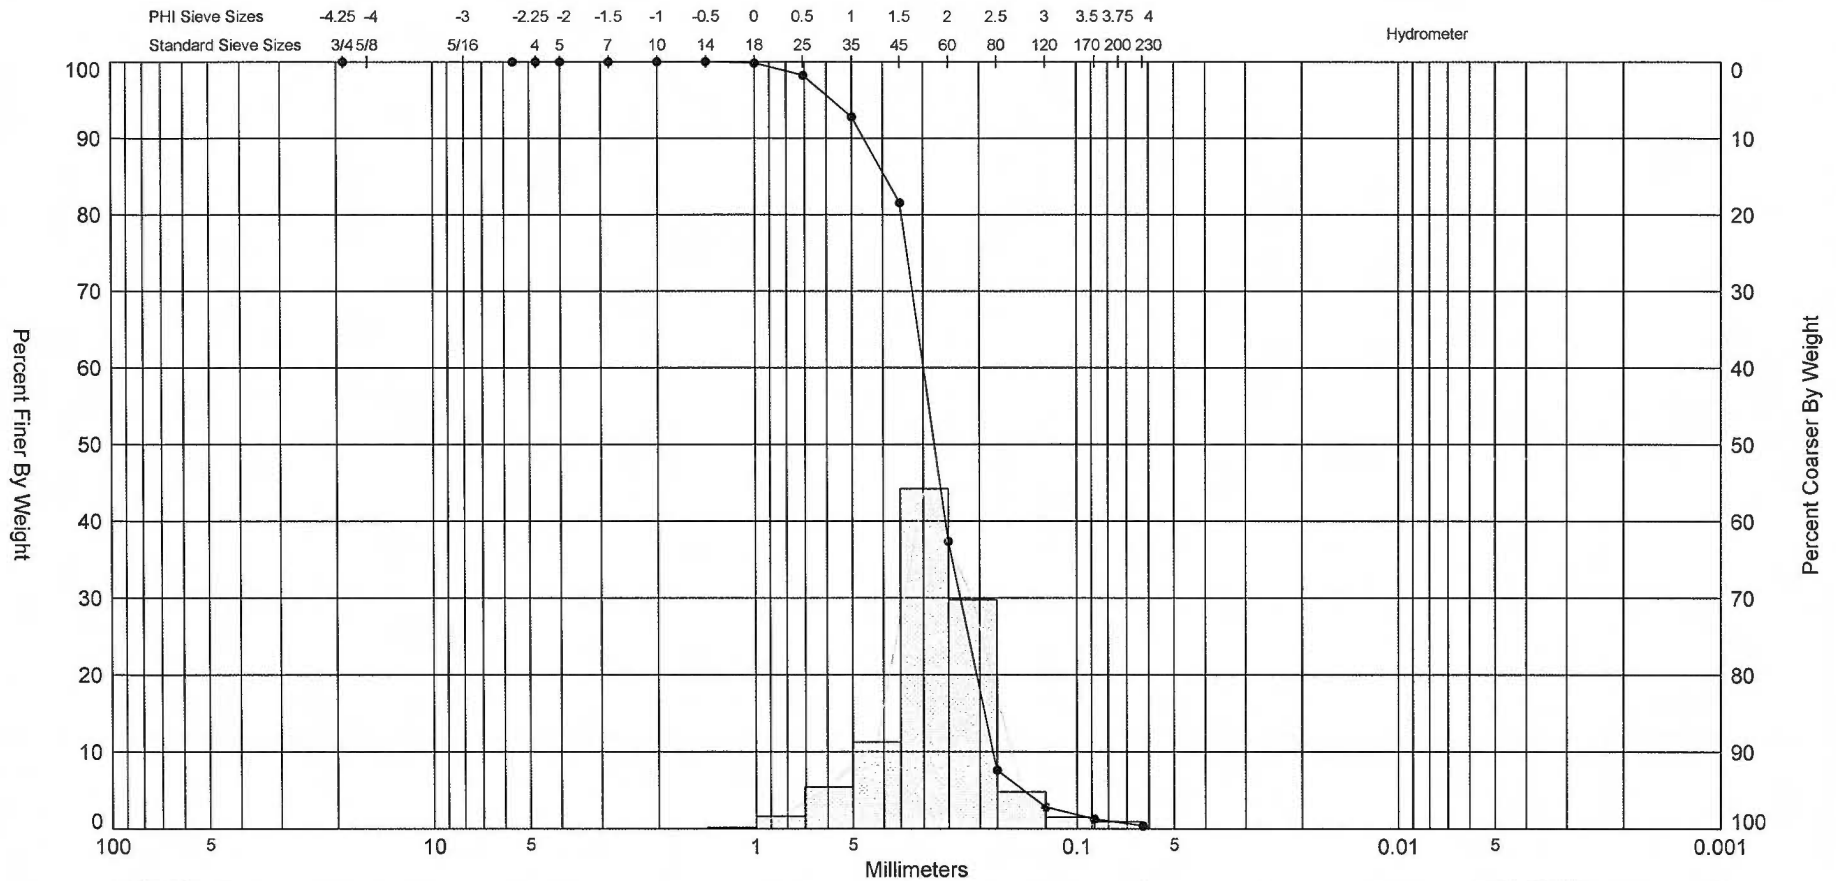
Gravel		Sand			Silt and Clay
Coarse	Fine	Coarse	Medium	Fine

Sample	Symbol	Elev. (ft)	USCS	% Fines	% Organics	% Carbonates	Median	Mean	Skew	Kurt	Sort	Sample Information	
Jl-16 PCC #S-1 (5')	—●—	-46.3	SP	#230 - 0.36			1.86	1.85	-0.13	4.7	0.56	Project Name:	Jupiter Island 10
Comments: 10 YR 5/1 Munsell @ 10% moisture												Analysis Date:	05-19-10
Depths and elevations based on measured values												Analyzed By:	ML
