SIEVE ANALYSIS JUPITER ISLAND 10.GPJ FL DEP ROSS.GDT 6/26/10

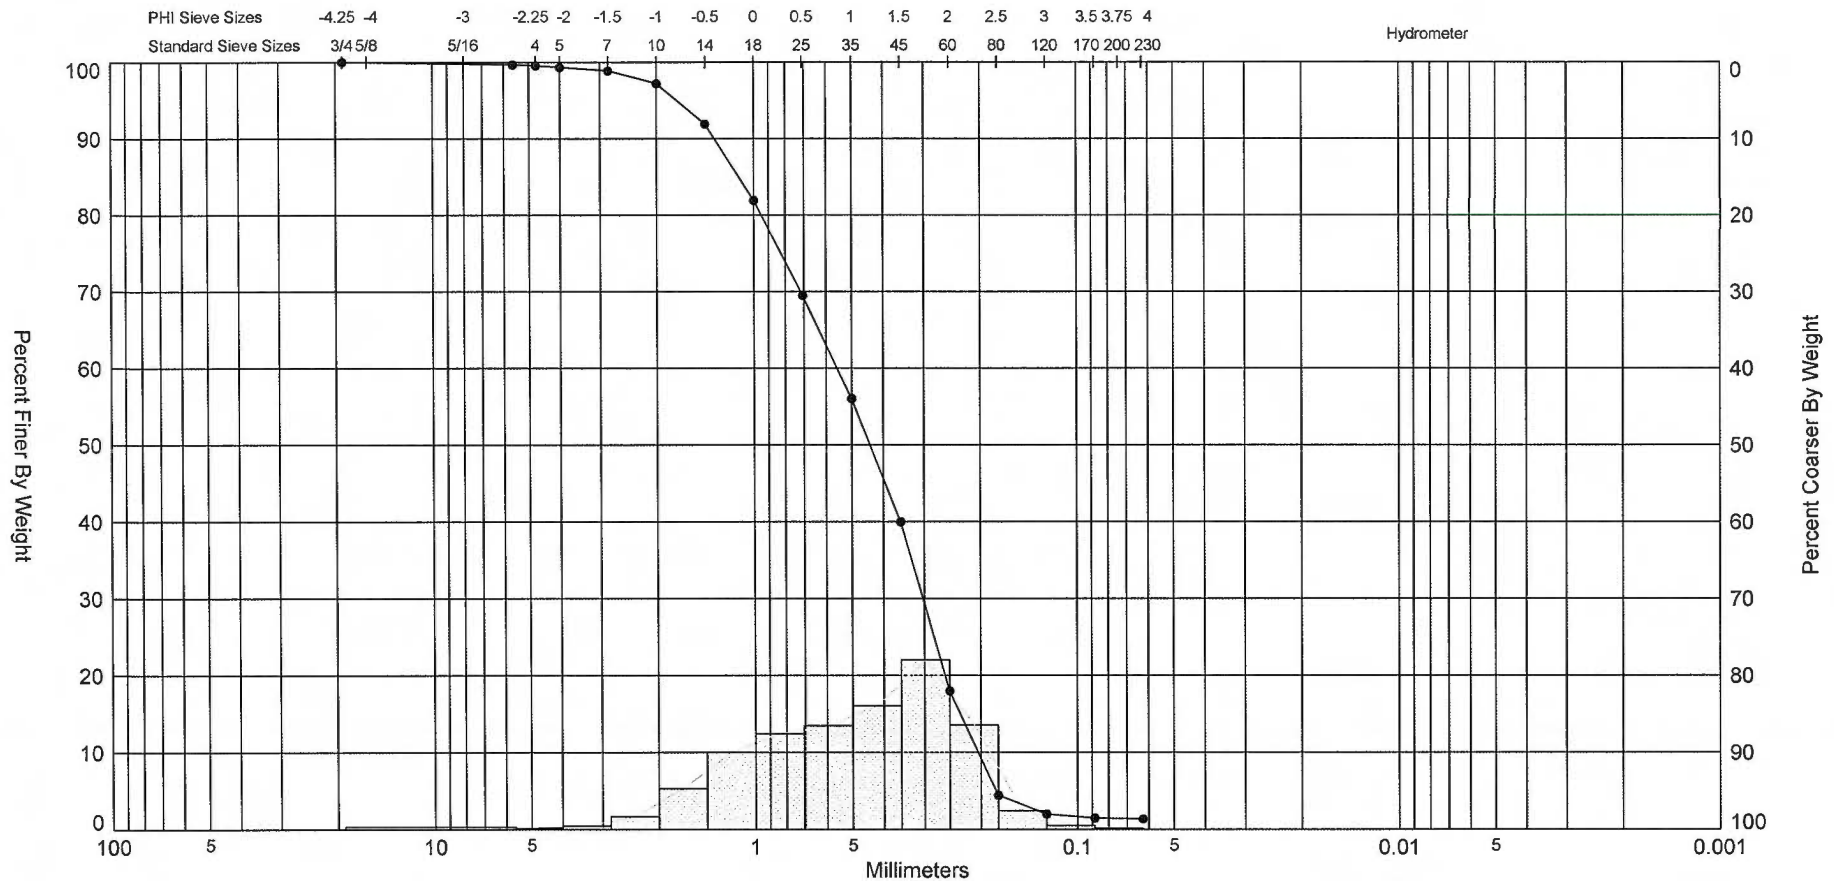
Gravel		Sand			Silt and Clay
Coarse	Fine	Coarse	Medium	Fine

Sample	Symbol	Elev. (ft)	USCS	% Fines	% Organics	% Carbonates	Median	Mean	Skew	Kurt	Sort	Sample Information	
Jl-18 #S-1 (3')	—●—	-47.4	SW	#230 - 1.33			1.19	1.01	-0.61	3.41	1.04	Project Name:	Jupiter Island 10
Comments: 10 YR 5/1 Munsell @ 10% Moisture												Analysis Date:	04-21-10
Depths and elevations based on measured values												Analyzed By:	JR

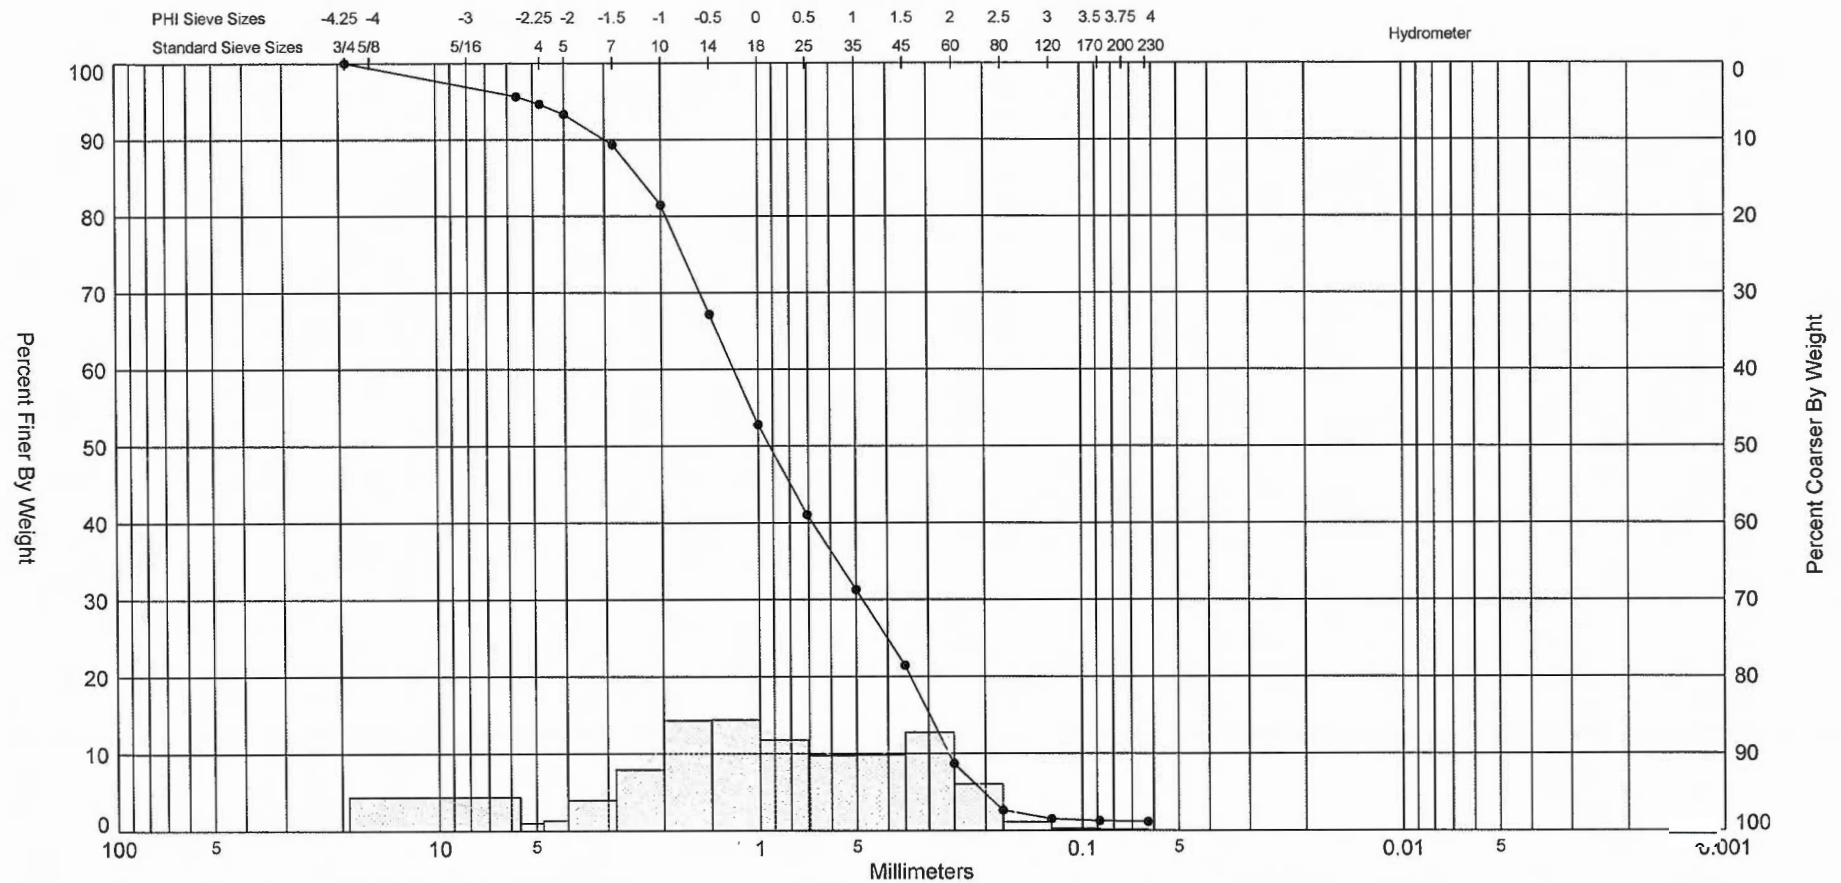
Gravel		Sand			Silt and Clay
Coarse	Fine	Coarse	Medium	Fine

Sample	Symbol	Elev. (ft)	USCS	% Fines	% Organics	% Carbonates	Median	Mean	Skew	Kurt	Sort	Sample Information	
J1-18 #S-2 (5.2')	—●—	-49.6	SW	#230 - 1.12		84.20	0.12	0.12	-0.39	2.88	1.41	Project Name:	Jupiter Island 10
Comments: 10 YR 5/1 Munsell @ 10% Moisture												Analysis Date:	04-23-10
Depths and elevations based on measured values												Analyzed By:	ML

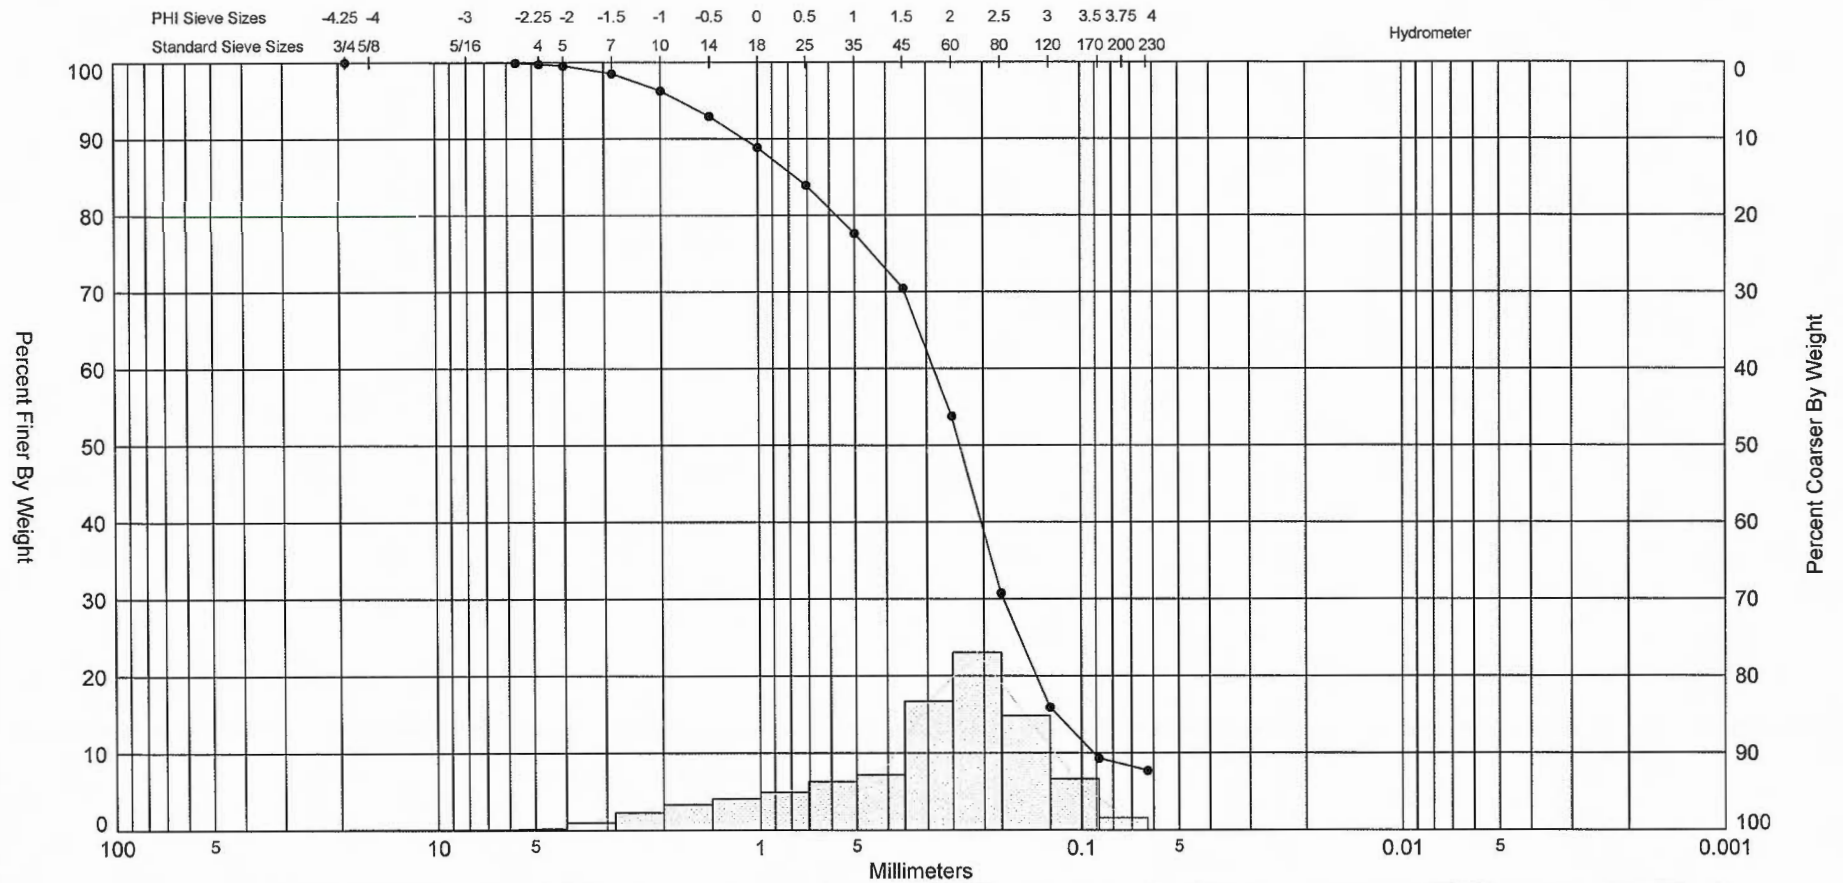
Gravel		Sand			Silt and Clay
Coarse	Fine	Coarse	Medium	Fine

Sample	Symbol	Elev. (ft)	USCS	% Fines	% Organics	% Carbonates	Median	Mean	Skew	Kurt	Sort	Sample Information	
JI-18 #S-3 (9.5')	—●—	-53.9	SW-SM	#230 - 7.69		67.90	2.08	1.68	-0.98	3.58	1.23	Project Name:	Jupiter Island 10
Comments: 10 YR 4/1 Munsell @ 10% Moisture												Analysis Date:	04-16-10
Depths and elevations based on measured values												Analyzed By:	ML

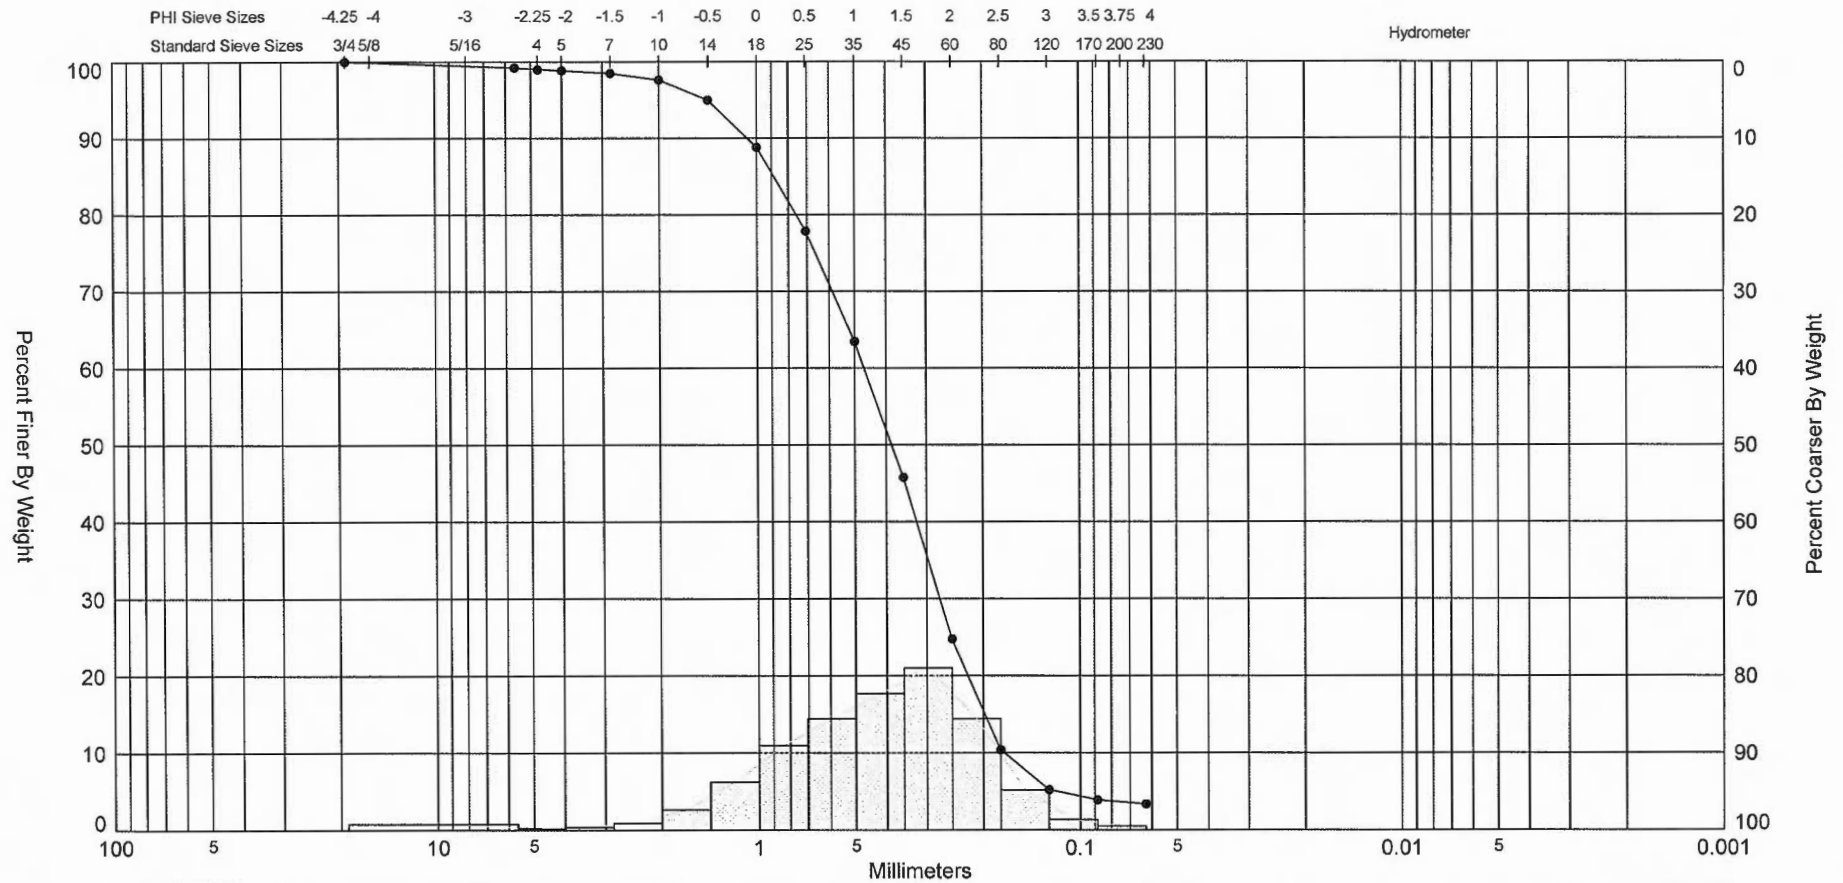
Gravel		Sand			Silt and Clay
Coarse	Fine	Coarse	Medium	Fine

Sample	Symbol	Elev. (ft)	USCS	% Fines	% Organics	% Carbonates	Median	Mean	Skew	Kurt	Sort	Sample Information	
JI-18 #S-4 (12')	—●—	-56.4	SW	#230 - 3.35			1.38	1.21	-0.9	5.12	1.06	Project Name:	Jupiter Island 10
Comments: 10 YR 5/1 Munsell @ 10% Moisture												Analysis Date:	04-21-10
Depths and elevations based on measured values												Analyzed By:	JR
