Project Name:	Singer Island 2012
---------------	--------------------

AMERICAN VIBRACORE
SERVICES

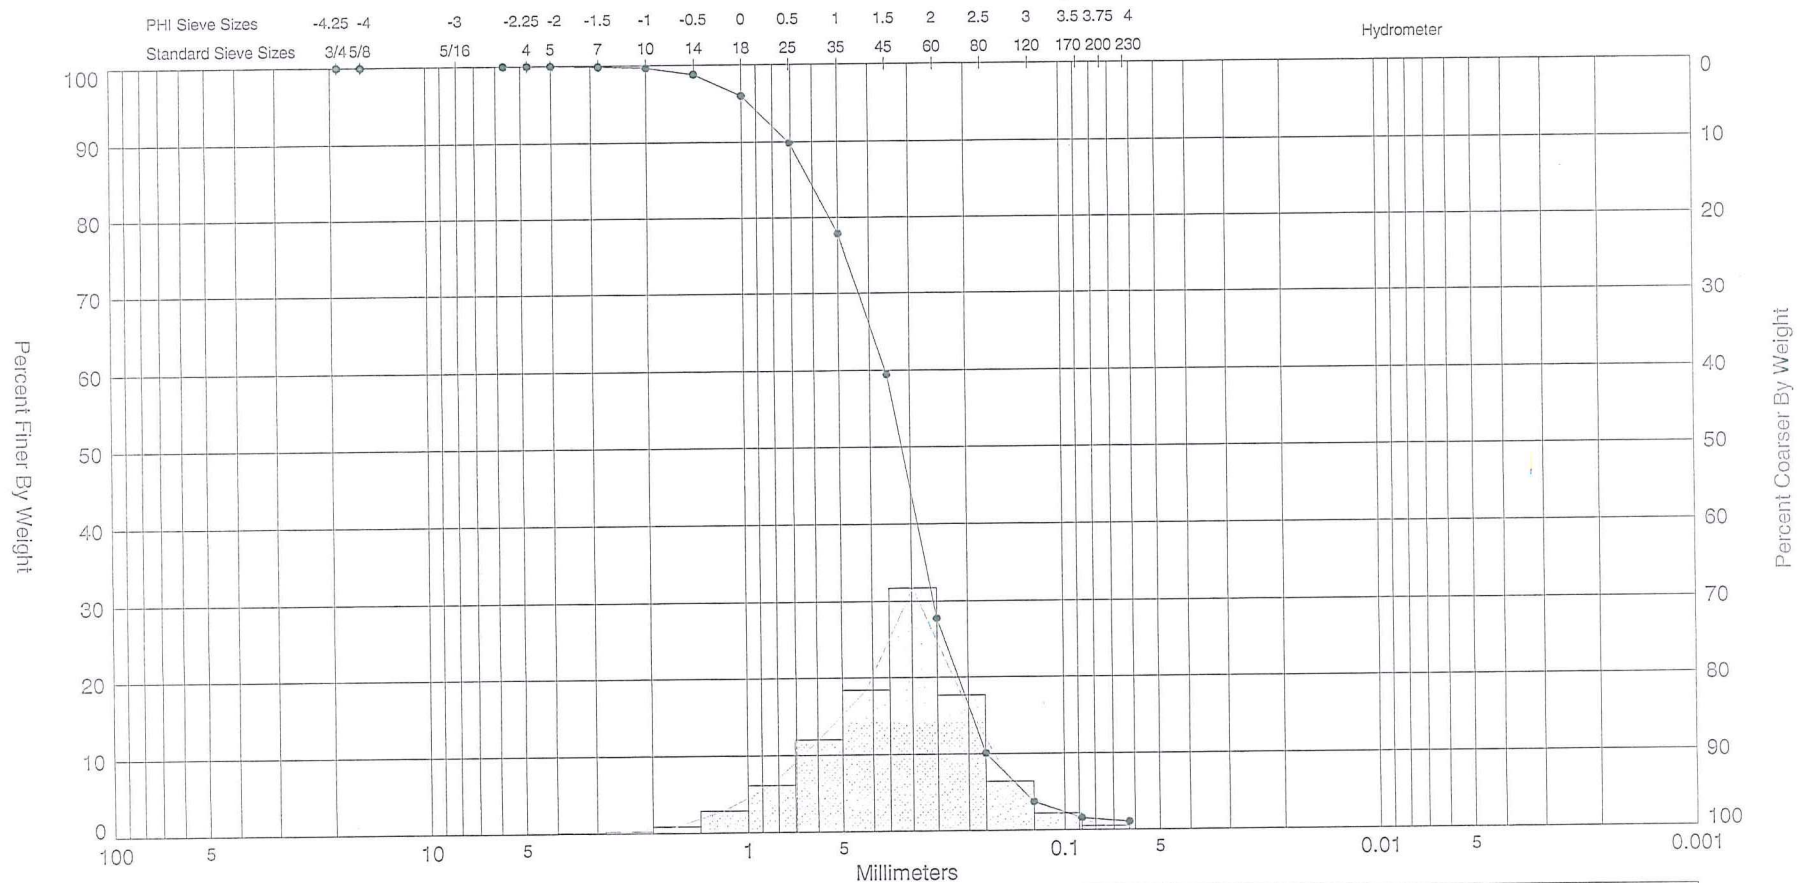
Sample	Symbol	Elev. (ft)	USCS	% Fines	% Organics	% Carbonates	Median	Mean	Skew	Kurt	Sort	Sample Information	
SIVC-12-6 #S-1 (1')	—●—	-68.7	SP	#230 - 1.04		69.60	1.65	1.55	-0.44	3.66	0.81	Project Name:	Singer Island 2012
Comments:												Analysis Date:	03-30-12
Depths and elevations based on measured values												Analyzed By:	ER

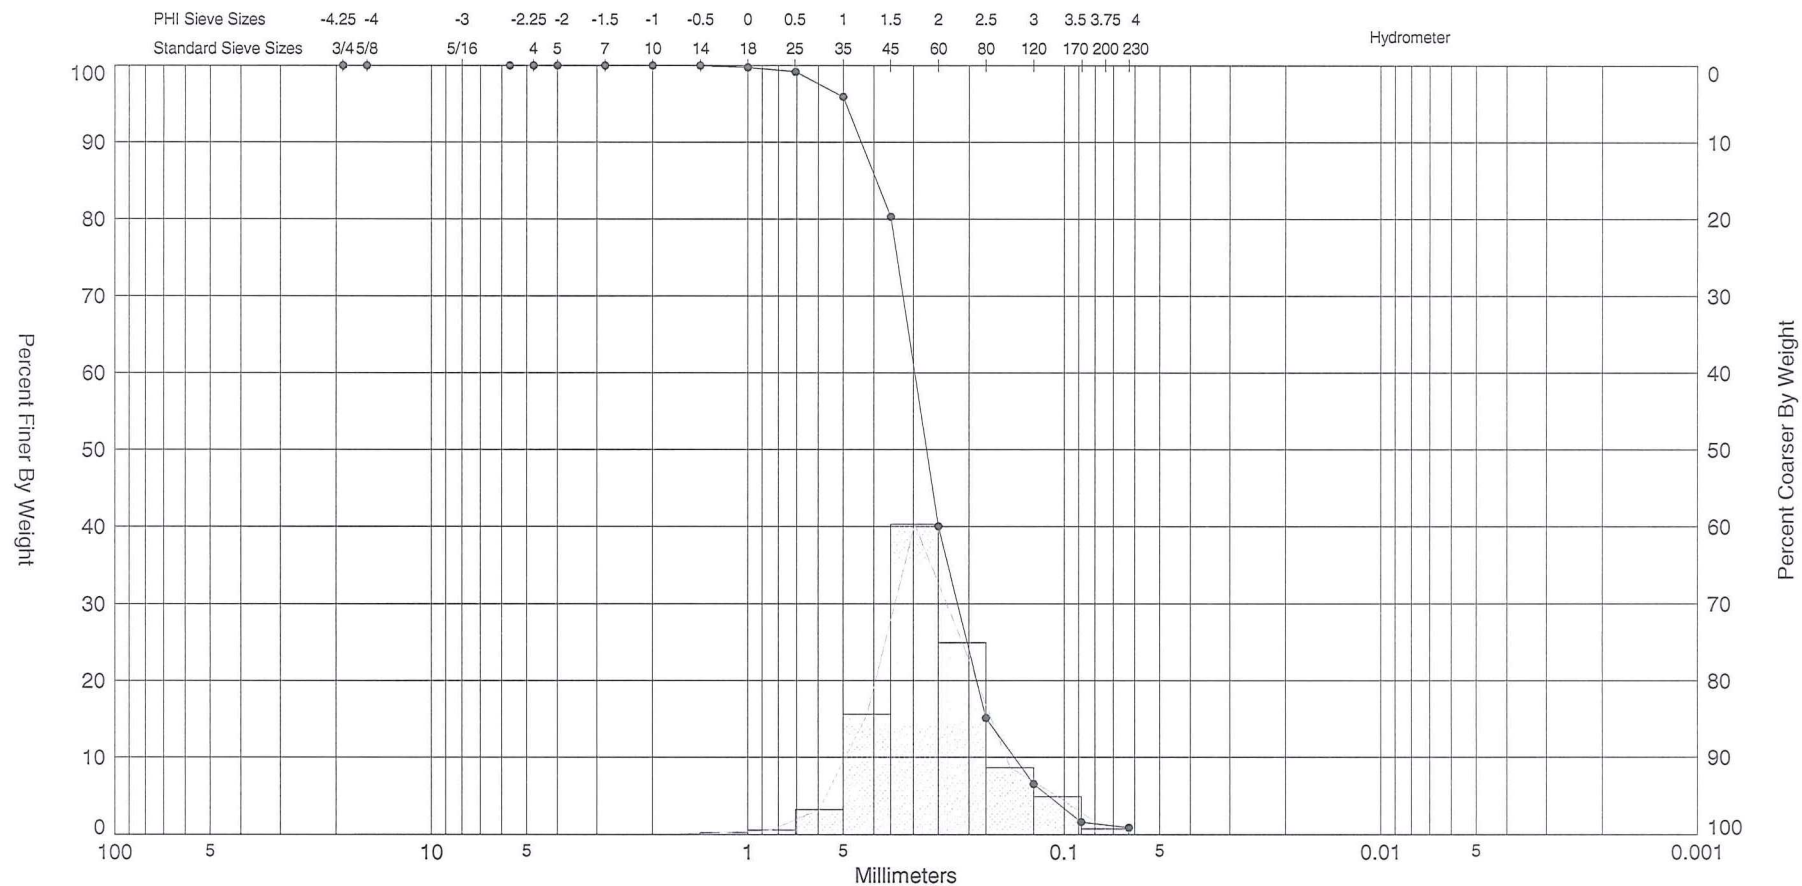
Sample	Symbol	Elev. (ft)	USCS	% Fines	% Organics	% Carbonates	Median	Mean	Skew	Kurt	Sort	Sample Information	
IVC-12-6 PCC #S-1 (1')	—●—	-68.7	SP	#230 - 0.90			1.88	1.93	0.28	3.77	0.6	Project Name:	Singer Island 2012
Comments:												Analysis Date:	04-05-12
Depths and elevations based on measured values												Analyzed By:	ER
