Sample	Symbol	Elev. (ft)	USCS	% Fines	% Organics	% Carbonates	Median	Mean	Skew	Kurt	Sort	Sample Information	
JI-6 #S-1 (3')	—●—	-44.8	SW	#230 - 1.46		61.90	1.25	1.06	-0.91	4.09	0.9	Project Name:	Jupiter Island 10
Comments: 10 YR 4/1 Munsell @ 10% Moisture												Analysis Date:	04-23-10
Depths and elevations based on measured values												Analyzed By:	JR

Easting (X, ft):	967434.
												Northing (Y, ft):	976919.
												Horizontal System:	NAD 1983
												Vertical System:	NAVD 88
American Vibracore Services, Inc. 1215 Wallace Drive Delray Beach, FL 33444

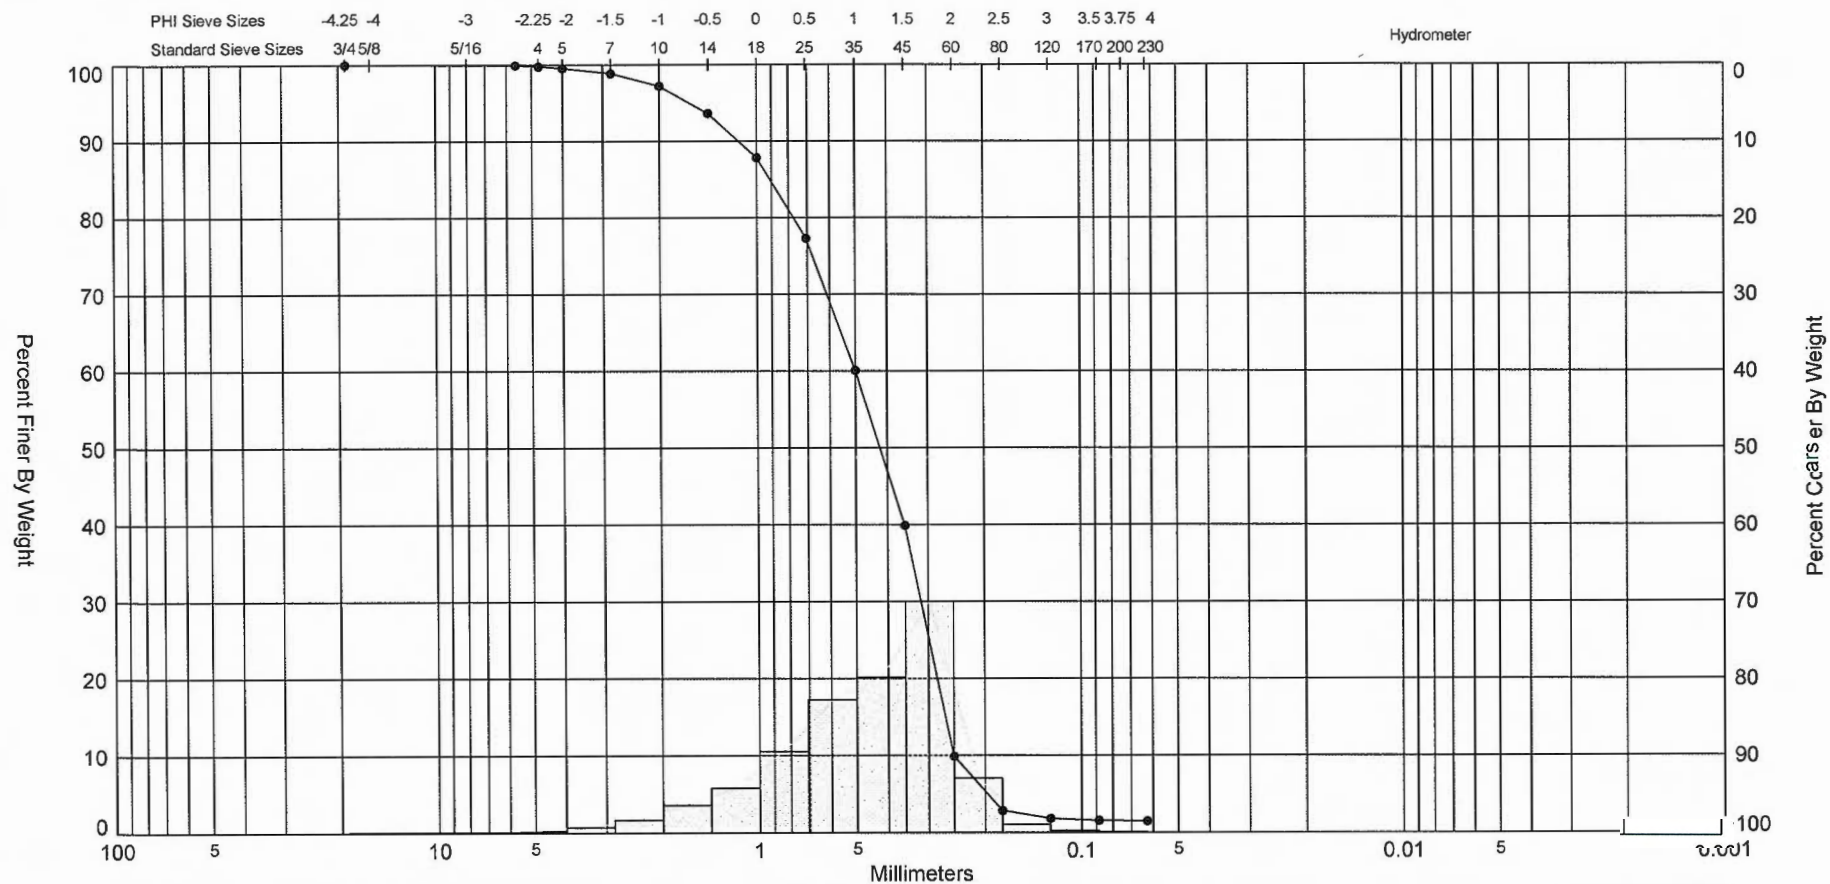
Gravel		Sand			Silt and Clay
Coarse	Fine	Coarse	Medium	Fine
