SIEVE ANALYSIS: JUPITER ISLAND 10.GPJ FL DEP ROSS.GDT 6/26/10

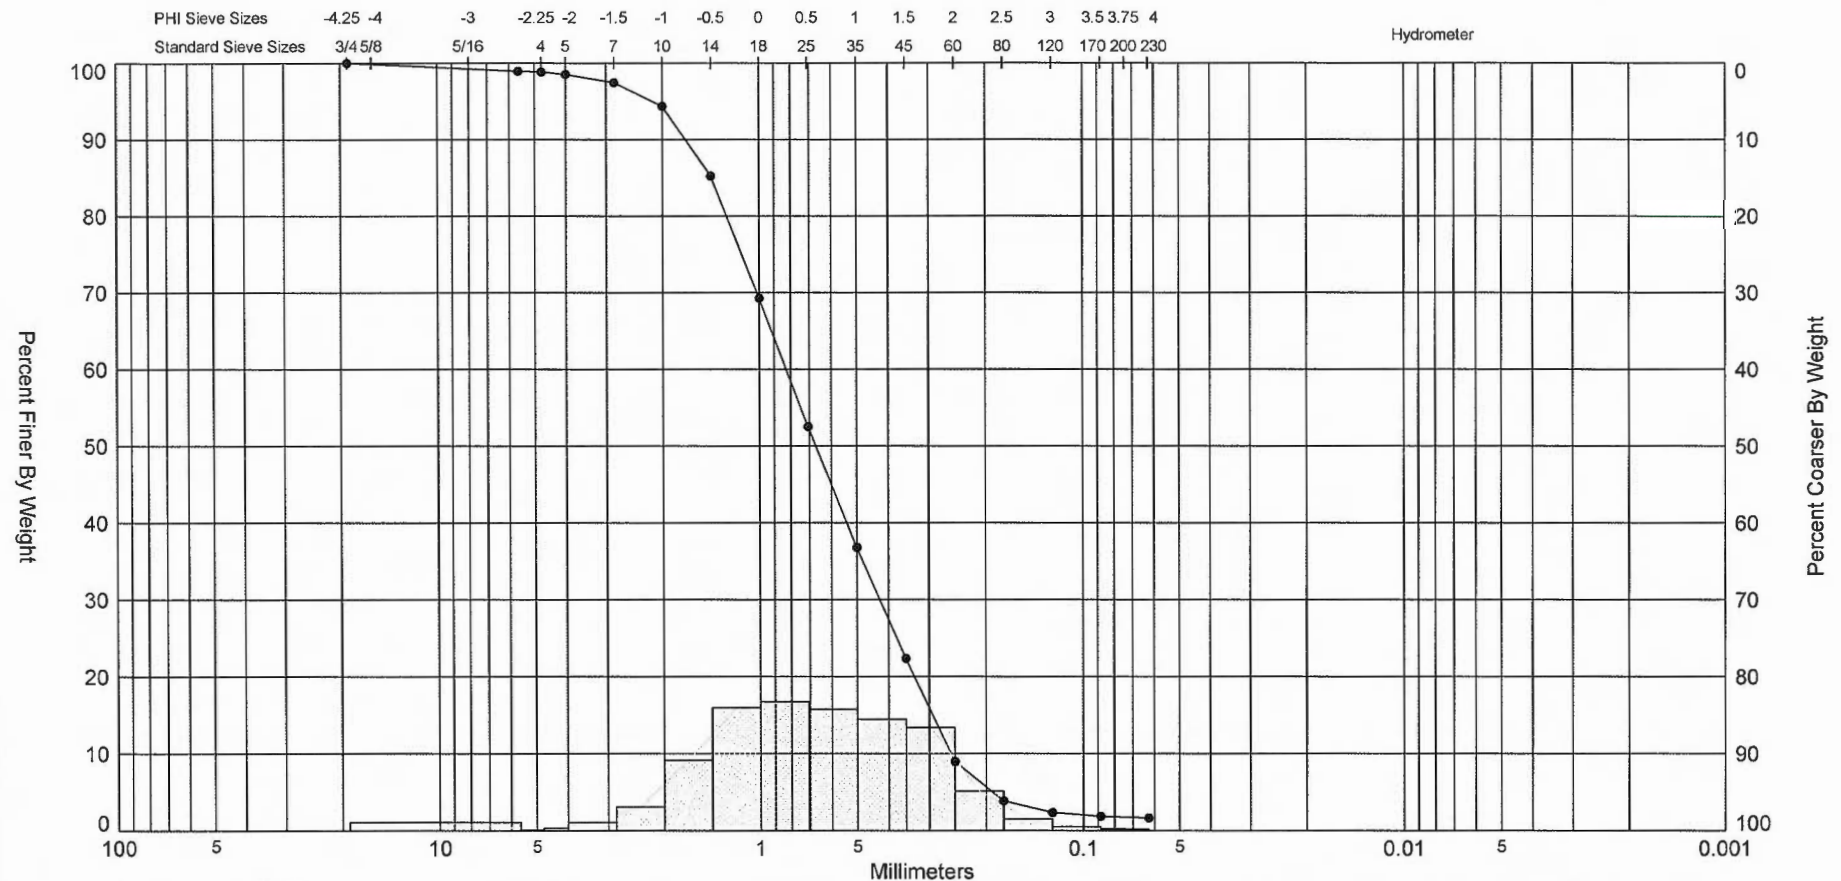
Sample	Symbol	Elev. (ft)	USCS	% Fines	% Organics	% Carbonates	Median	Mean	Skew	Kurt	Sort	Sample Information	
Jl-15B #S-1 (2')	—●—	-43.9	SW	#230 - 1.64		80.70	0.58	0.55	-0.38	3.79	1.09	Project Name:	Jupiter Island 10
Comments: 10 YR 5/1 Munsell @ 10% Moisture												Analysis Date:	04-16-10
Depths and elevations based on measured values												Analyzed By:	ML
