Sample	Symbol	Elev. (ft)	USCS	% Fines	% Organics	% Carbonates	Median	Mean	Skew	Kurt	Sort	Sample Information	
JIVC-10-51 #S-1 (2')	—●—	-50.2	SP	#230 - 1.14			1.62	1.51	-0.71	5.45	0.56	Project Name:	Jupiter Island 10 Detail Phase
Comments: Visual Shell Content = 0%												Analysis Date:	11-17-10
Depths and elevations based on measured values												Analyzed By:	CA

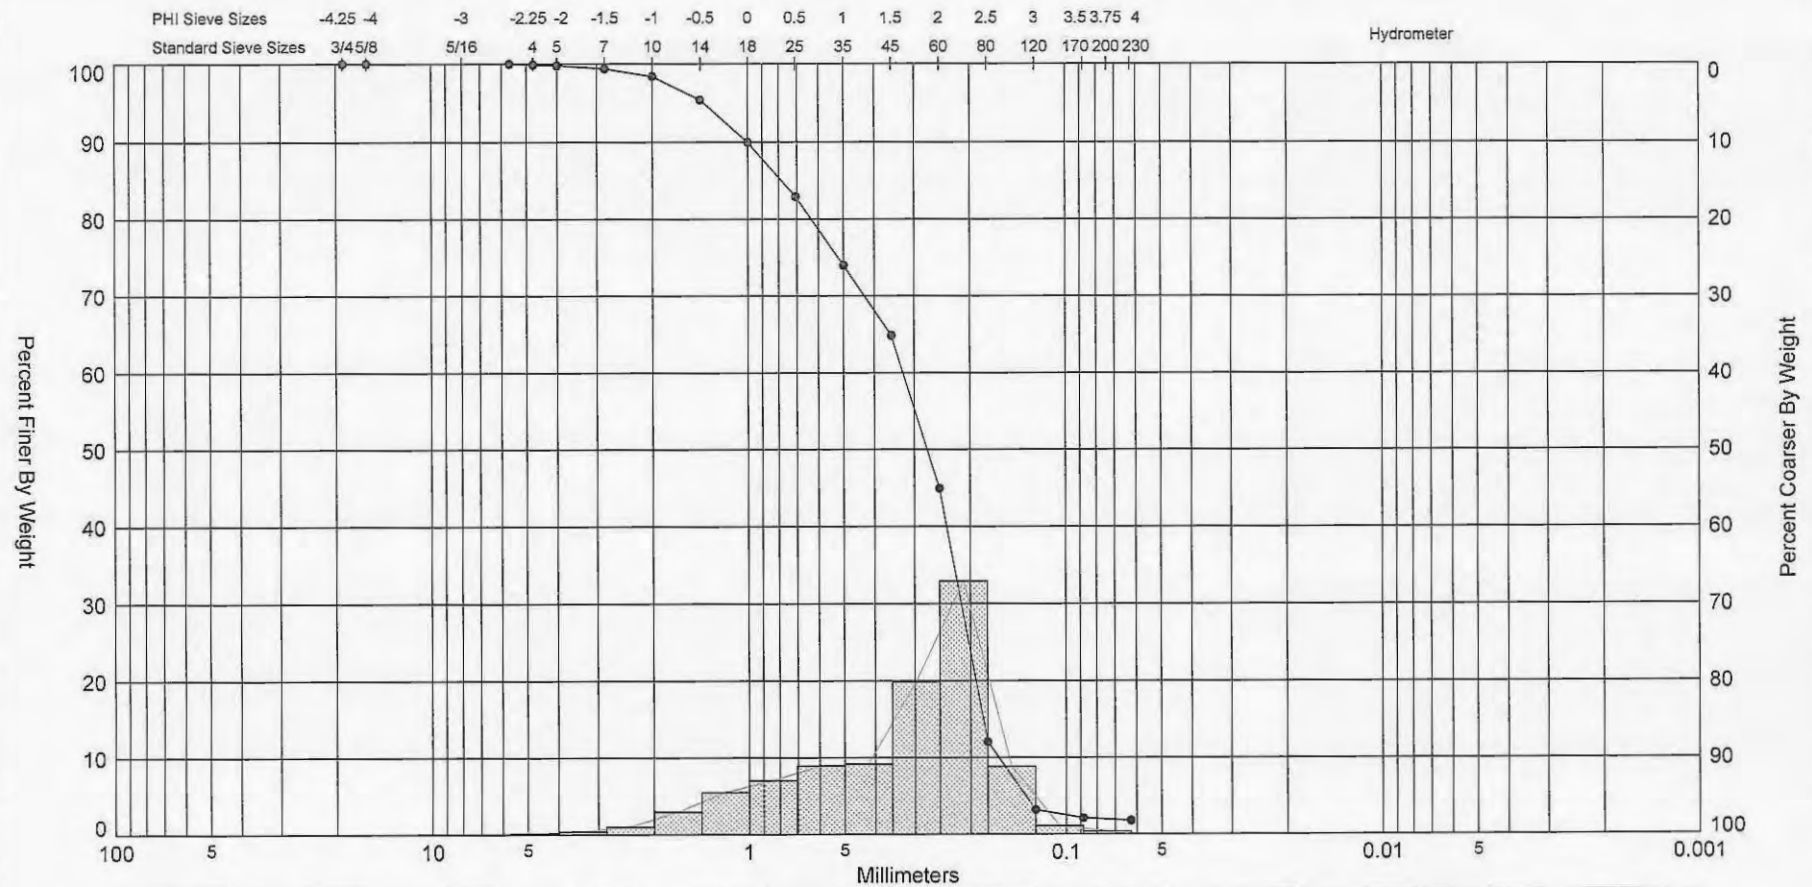
Sample	Symbol	Elev. (ft)	USCS	% Fines	% Organics	% Carbonates	Median	Mean	Skew	Kurt	Sort	Sample Information	
JIVC-10-51 #S-3 (8')		-56.2	SW	#230 - 1.78		75.80	1.87	1.55	-0.96	3.43	1.02	Project Name:	Jupiter Island 10 Detail Phase
Comments: Visual Shell Content = >1%												Analysis Date:	11-10-10
Depths and elevations based on measured values												Analyzed By:	JR

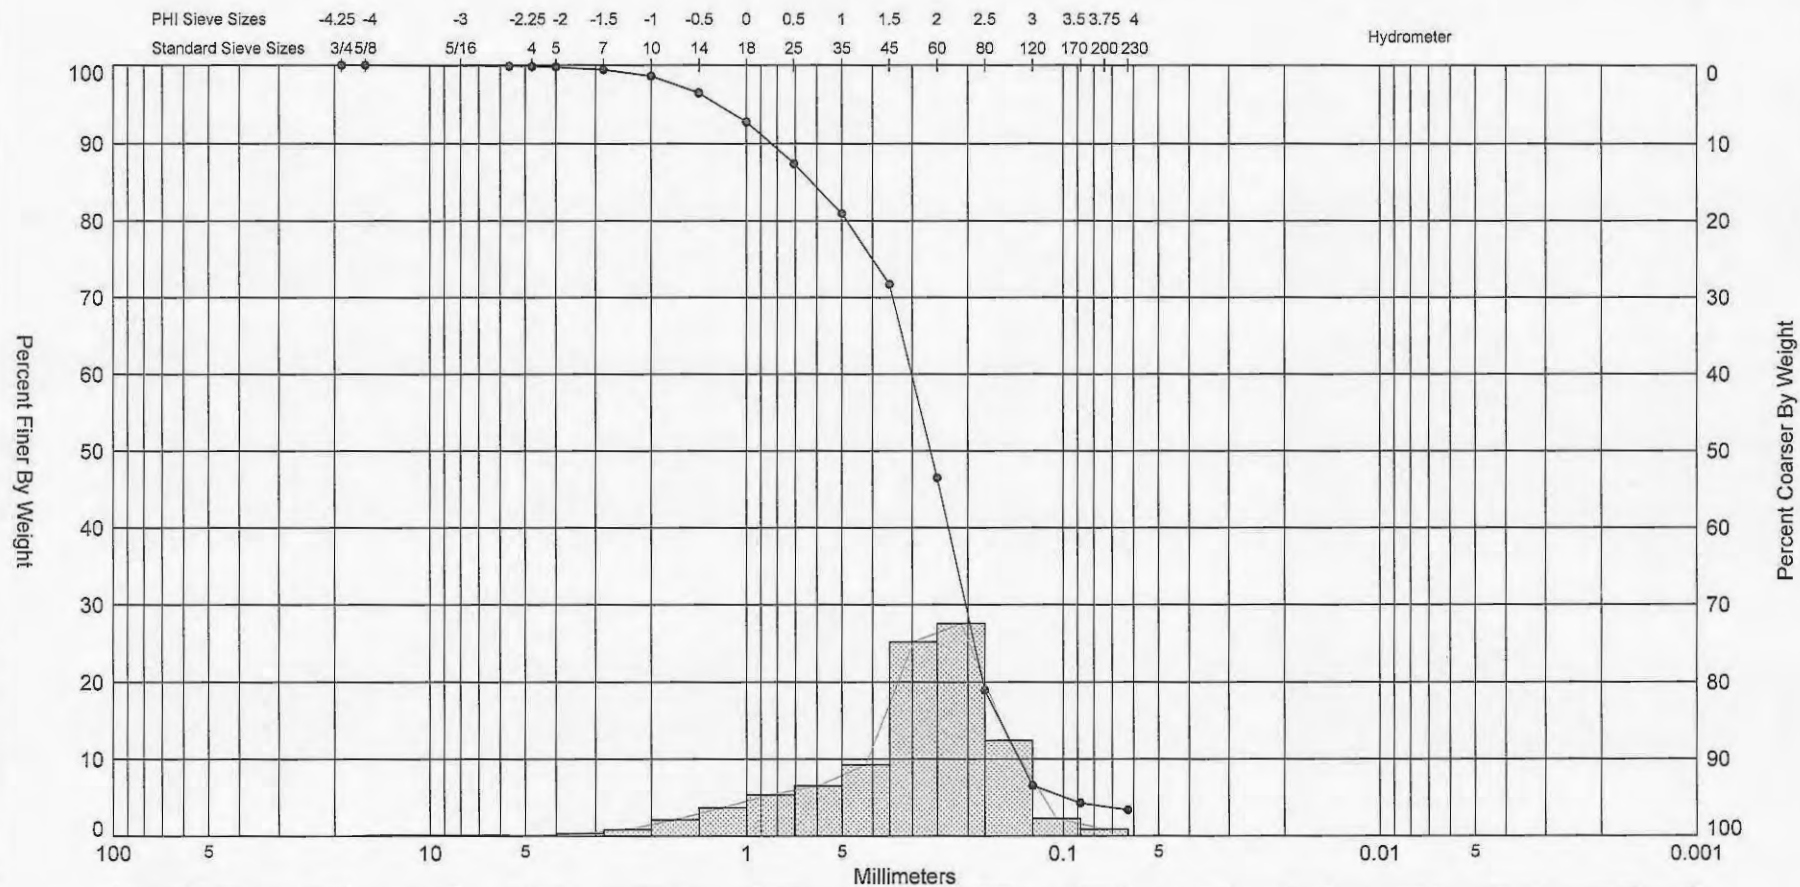
Sample	Symbol	Elev. (ft)	USCS	% Fines	% Organics	% Carbonates	Median	Mean	Skew	Kurt	Sort	Sample Information	
JIVC-10-51 #S-4 (10')	—●—	-58.2	SW	#230 - 3.38			1.93	1.7	-1.13	4.7	0.98	Project Name:	Jupiter Island 10 Detail Phase
Comments: Visual Shell Content = >1%												Analysis Date:	11-17-10
Depths and elevations based on measured values												Analyzed By:	CA
