Sample	Symbol	Elev. (ft)	USCS	% Fines	% Organics	% Carbonates	Median	Mean	Skew	Kurt	Sort	Sample Information	
JIVC-10-5 #S-1 (0.5')	—●—	-47.4	SW	#230 - 1.07			0.91	0.67	-0.8	3.61	1.1	Project Name:	Jupiter Island 10 Detail Phase
Comments: Visual Shell Content = 2%												Analysis Date:	11-11-10
Depths and elevations based on measured values												Analyzed By:	JR

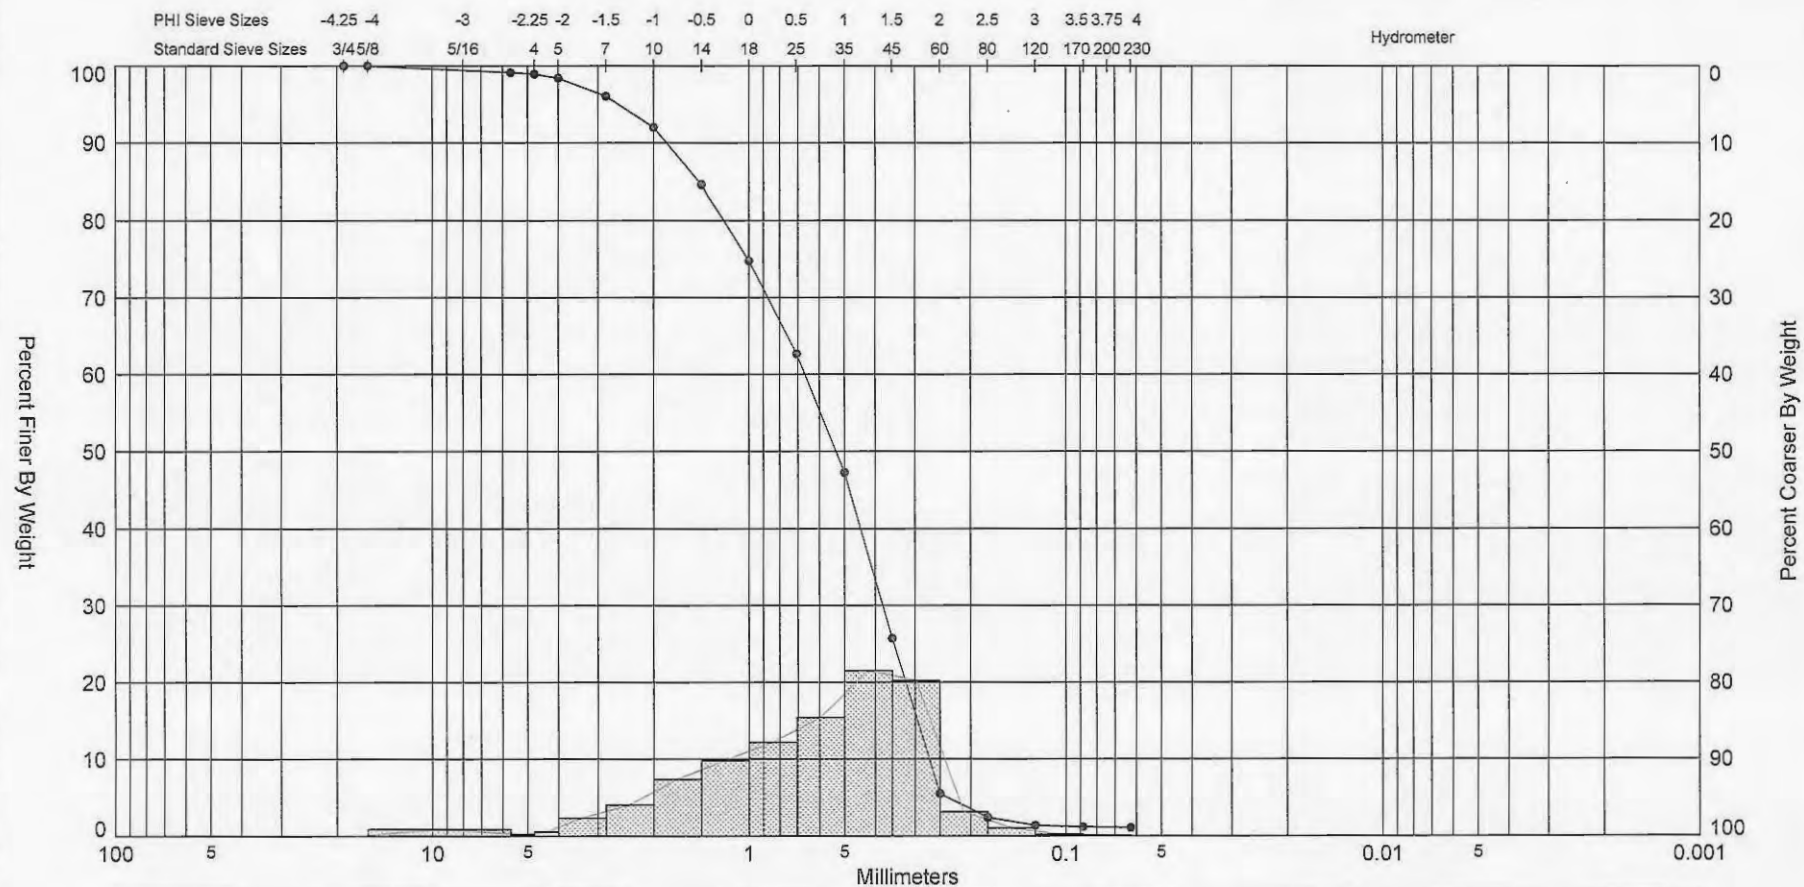
Gravel		Sand			Silt and Clay
Coarse	Fine	Coarse	Medium	Fine

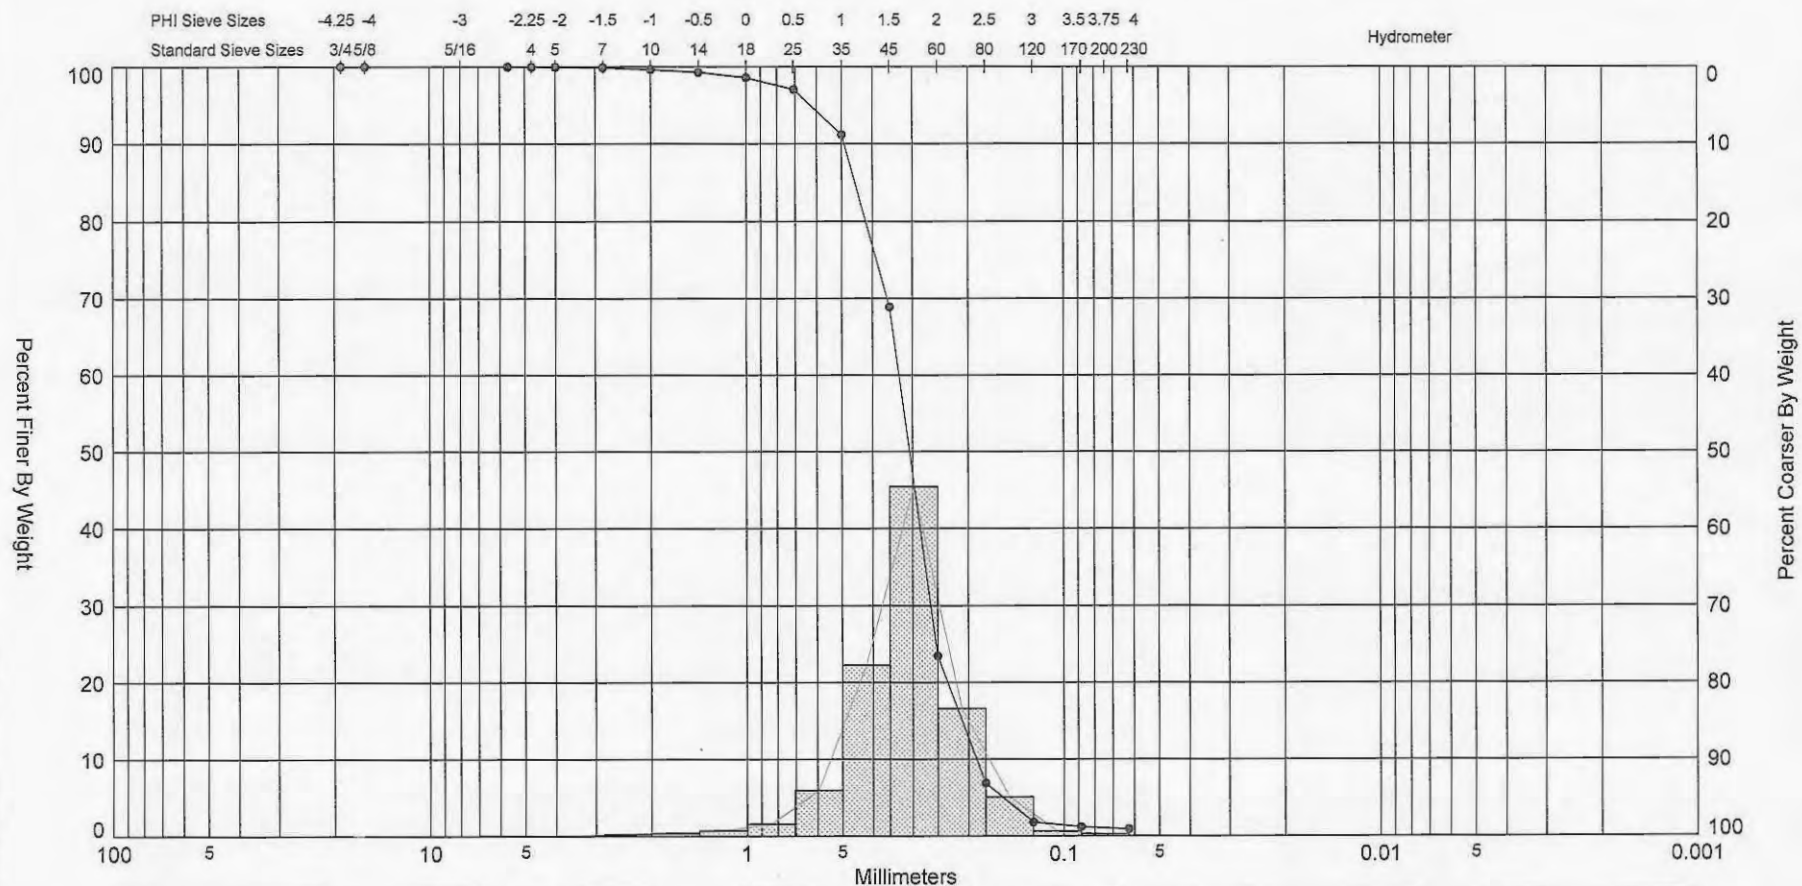
Gravel		Sand			Silt and Clay
Coarse	Fine	Coarse	Medium	Fine

Sample	Symbol	Elev. (ft)	USCS	% Fines	% Organics	% Carbonates	Median	Mean	Skew	Kurt	Sort	Sample Information	
JIVC-10-5 #S-2 (5.5')		-52.4	SP	#230 - 0.88		61.90	1.71	1.67	-0.95	8.1	0.6	Project Name:	Jupiter Island 10 Detail Phase
Comments: Visual Shell Content = >1%												Analysis Date:	11-08-10
Depths and elevations based on measured values												Analyzed By:	JR

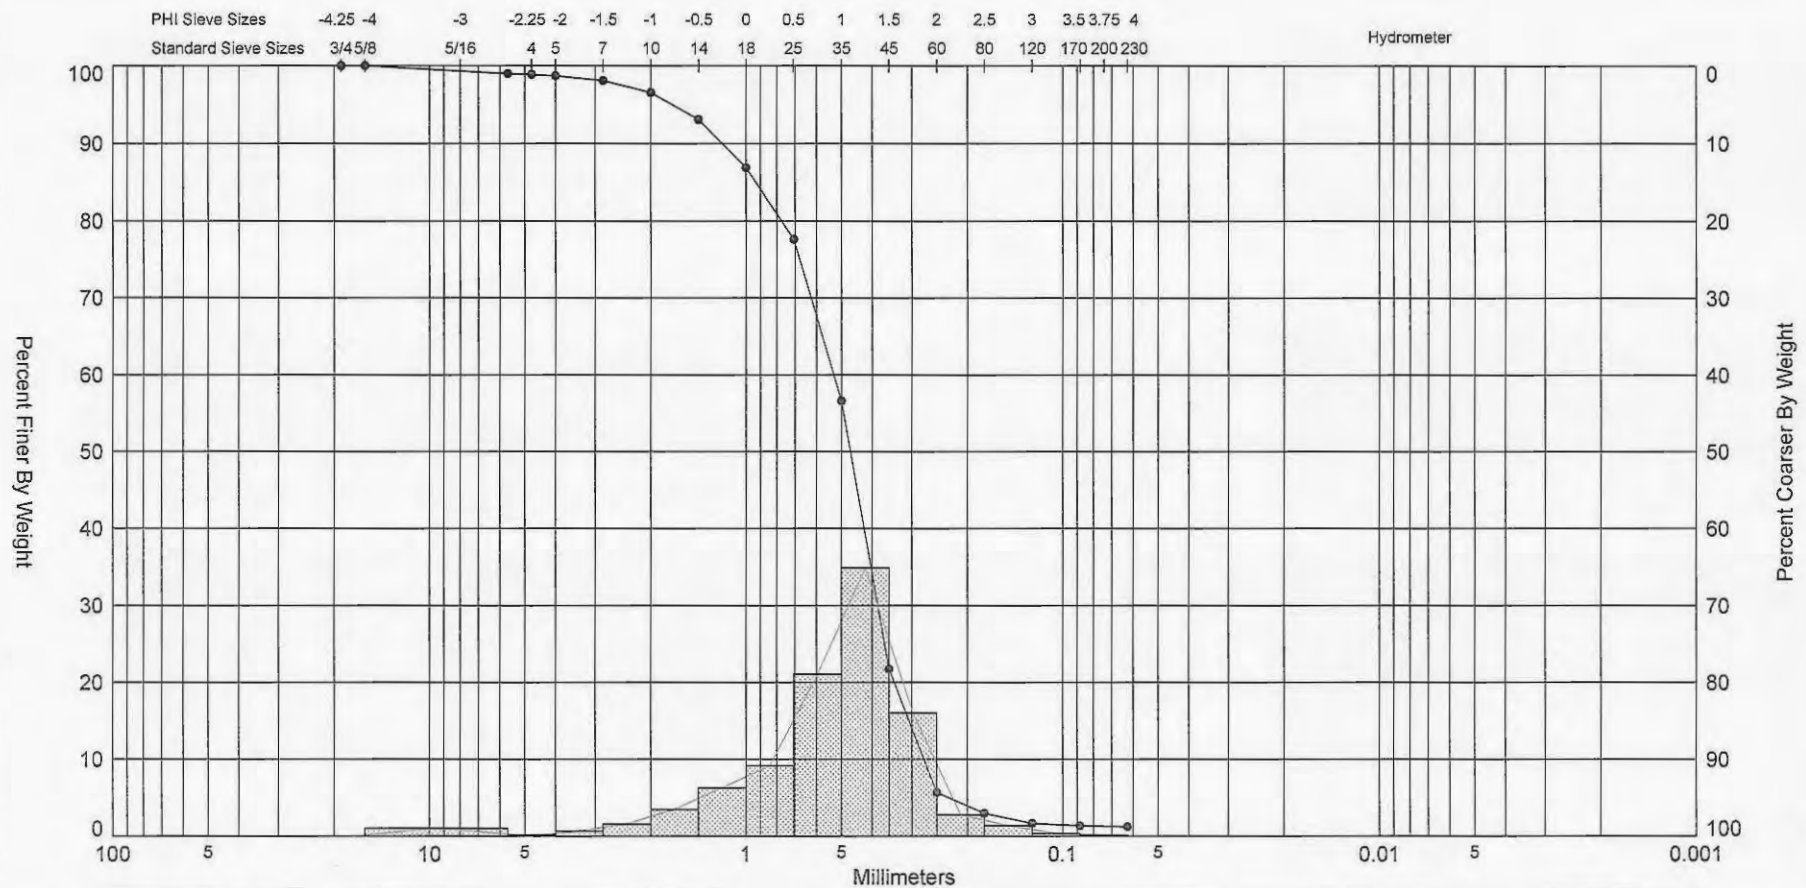
Gravel		Sand			Silt and Clay
Coarse	Fine	Coarse	Medium	Fine

Sample	Symbol	Elev. (ft)	USCS	% Fines	% Organics	% Carbonates	Median	Mean	Skew	Kurt	Sort	Sample Information	
JIVC-10-5 #S-3 (9')	—●—	-55.9	SW	#230 - 1.21			1.09	0.91	-1.4	7.13	0.91	Project Name:	Jupiter Island 10 Detail Phase
Comments: Visual Shell Content = 2%												Analysis Date:	11-11-10
Depths and elevations based on measured values												Analyzed By:	JR

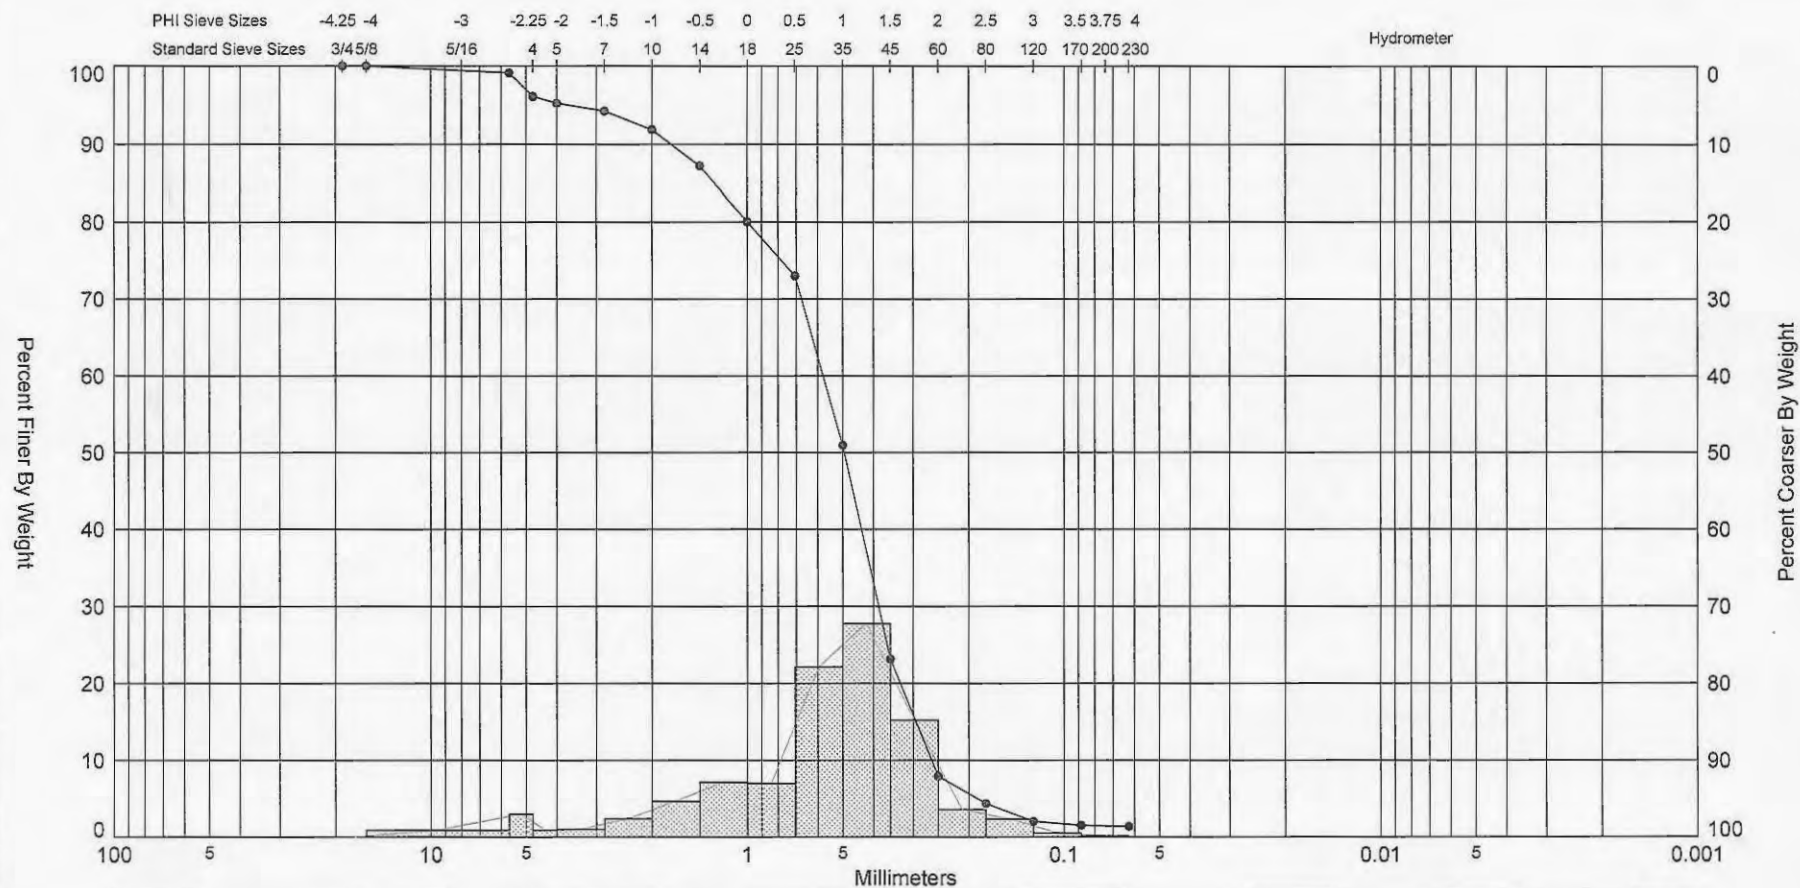
Gravel		Sand			Silt and Clay
Coarse	Fine	Coarse	Medium	Fine

Sample	Symbol	Elev. (ft)	USCS	% Fines	% Organics	% Carbonates	Median	Mean	Skew	Kurt	Sort	Sample Information	
JIVC-10-5 #S-4 (12')	—●—	-58.9	SW	#230 - 1.37		79.70	1.02	0.76	-1.13	4.61	1.15	Project Name:	Jupiter Island 10 Detail Phase
Comments: Visual Shell Content = 4%												Analysis Date:	11-22-10
Depths and elevations based on measured values												Analyzed By:	JR
<div style="display: flex; align-items: center;"> <div> <b>American Vibracore Services, Inc.</b>                      1215 Wallace Drive                      Delray Beach, FL 33444                 </div> </div>												Easting (X, ft):	966481.
												Northing (Y, ft):	976621.
												Horizontal System:	NAD 1983
												Vertical System:	NAVD 88
