SIEVE ANALYSIS: SINGER_IS.GPJ FL DEP ROSS.GDT 9/7/04

Sample	Symbol	Elev.	Comments	USCS	% Fines	Median	Mean	Skew	Kurt	Sort	Sample Information	
SI04-18 #1.0	—●—	-31.9		SP	#200 - 1.12 #230 - 0.60	3.11	3.03	-2.79	16.85	0.44	Project Name:	Palm Beach County Vibracore 2004
											Analysis Date:	07-01-04
											Analyzed By:	SEA Inc.
Scientific Environmental Applications, Inc. 5575 Willoughby Drive Melbourne, FL 32934 (321) 254-2708 Seapp1@aol.com											Easting (X):	973,611
											Northing (Y):	901,388
											Horizontal System:	NAD 1983
											Vertical System:	NAVD 29

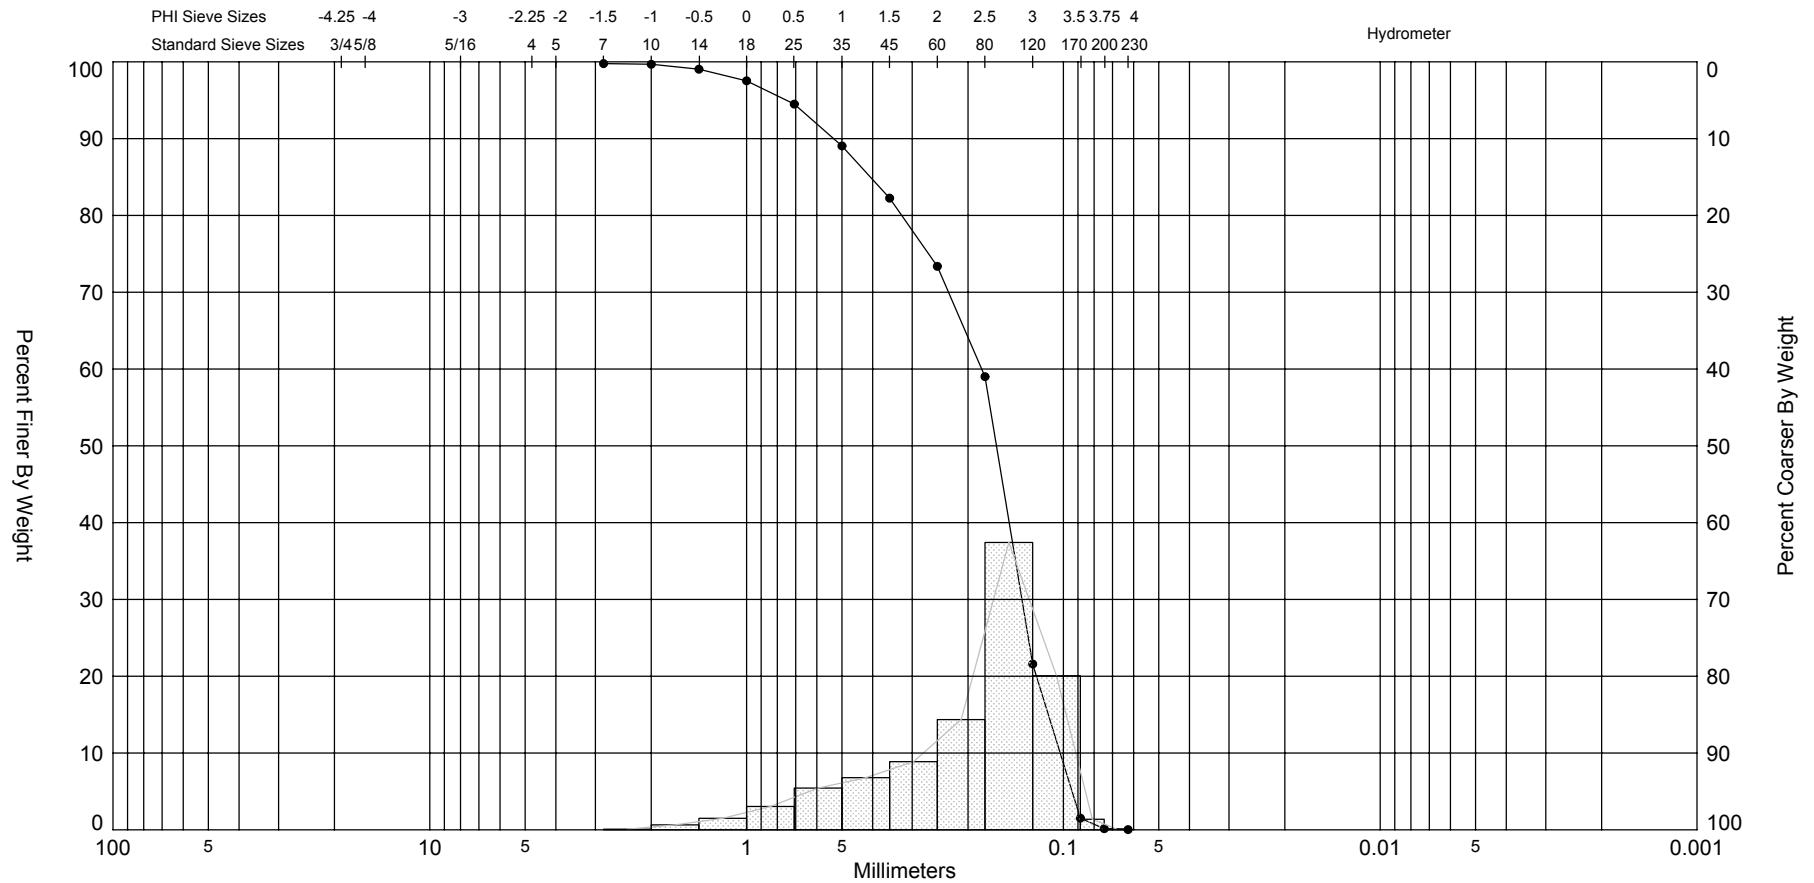
SIEVE ANALYSIS: SINGER_IS.GPJ FL DEP ROSS.GDT 9/7/04

Sample	Symbol	Elev.	Comments	USCS	% Fines	Median	Mean	Skew	Kurt	Sort	Sample Information	
SI04-18 #4.0	—●—	-34.9		SP	#200 - 0.15 #230 - 0.03	2.62	2.34	-1.22	4.02	0.9	Project Name:	Palm Beach County Vibracore 2004
											Analysis Date:	07-01-04
											Analyzed By:	SEA Inc.
Scientific Environmental Applications, Inc. 5575 Willoughby Drive Melbourne, FL 32934 (321) 254-2708 Seapp1@aol.com											Easting (X):	973,611
											Northing (Y):	901,388
											Horizontal System:	NAD 1983
											Vertical System:	NAVD 29

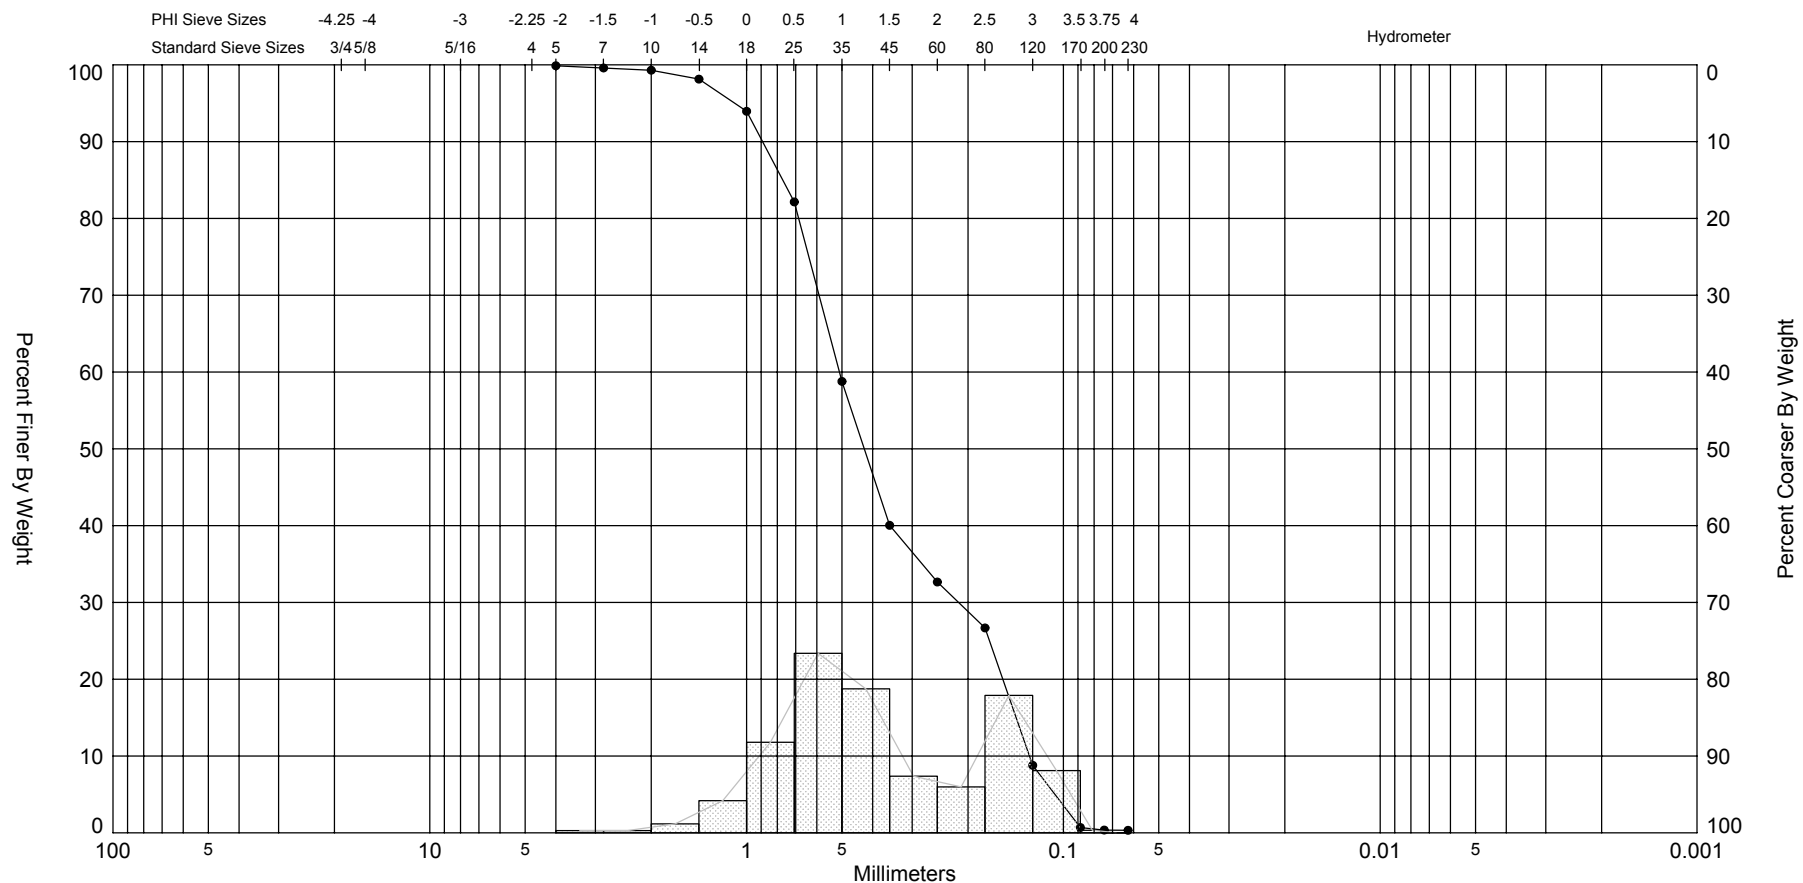
SIEVE ANALYSIS: SINGER_IS.GPJ FL DEP ROSS.GDT 9/7/04

Sample	Symbol	Elev.	Comments	USCS	% Fines	Median	Mean	Skew	Kurt	Sort	Sample Information	
SI04-18 #11.0	—●—	-41.9		SP	#200 - 0.36 #230 - 0.33	1.23	1.45	0.14	2.16	1.07	Project Name:	Palm Beach County Vibracore 2004
											Analysis Date:	07-01-04
											Analyzed By:	SEA Inc.
Scientific Environmental Applications, Inc. 5575 Willoughby Drive Melbourne, FL 32934 (321) 254-2708 Seapp1@aol.com											Easting (X):	973,611
											Northing (Y):	901,388
											Horizontal System:	NAD 1983
											Vertical System:	NAVD 29

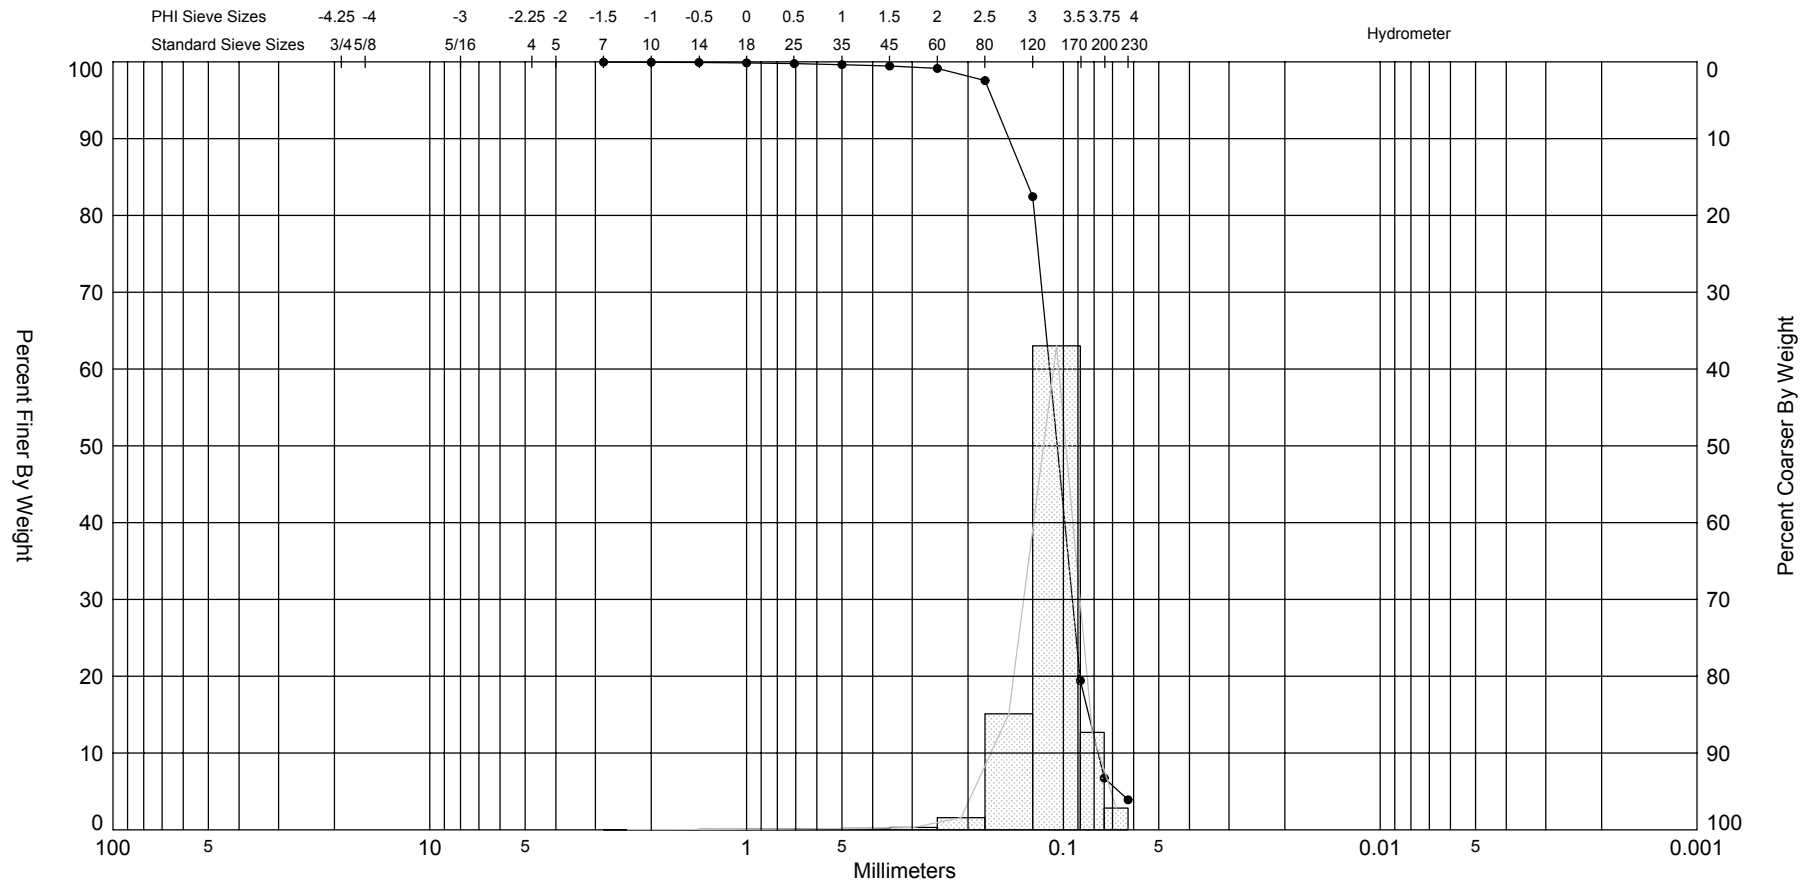
SIEVE ANALYSIS: SINGER_IS.GPJ FL DEP ROSS.GDT 9/7/04

Sample	Symbol	Elev.	Comments	USCS	% Fines	Median	Mean	Skew	Kurt	Sort	Sample Information	
SI04-18 #15.0	—●—	-45.9		SP	#200 - 6.74 #230 - 1.38	2.58	2.06	-0.75	2.48	1.21	Project Name:	Palm Beach County Vibracore 2004
											Analysis Date:	07-01-04
											Analyzed By:	SEA Inc.
Scientific Environmental Applications, Inc. 5575 Willoughby Drive Melbourne, FL 32934 (321) 254-2708 Seapp1@aol.com											Easting (X):	973,611
											Northing (Y):	901,388
											Horizontal System:	NAD 1983
											Vertical System:	NAVD 29
