SIEVE ANALYSIS: SINGER_IS.GPJ FL DEP ROSS.GDT 9/7/04

Sample	Symbol	Elev.	Comments	USCS	% Fines	Median	Mean	Skew	Kurt	Sort	Sample Information	
SI04-17 #4.0	—●—	-56.5		SP	#200 - 1.07 #230 - 1.60	1.9	1.77	-0.62	3.23	0.85	Project Name:	Palm Beach County Vibracore 2004
											Analysis Date:	07-01-04
											Analyzed By:	SEA Inc.
Scientific Environmental Applications, Inc. 5575 Willoughby Drive Melbourne, FL 32934 (321) 254-2708 Seapp1@aol.com											Easting (X):	974,944
											Northing (Y):	898,466
											Horizontal System:	NAD 1983
											Vertical System:	NAVD 29

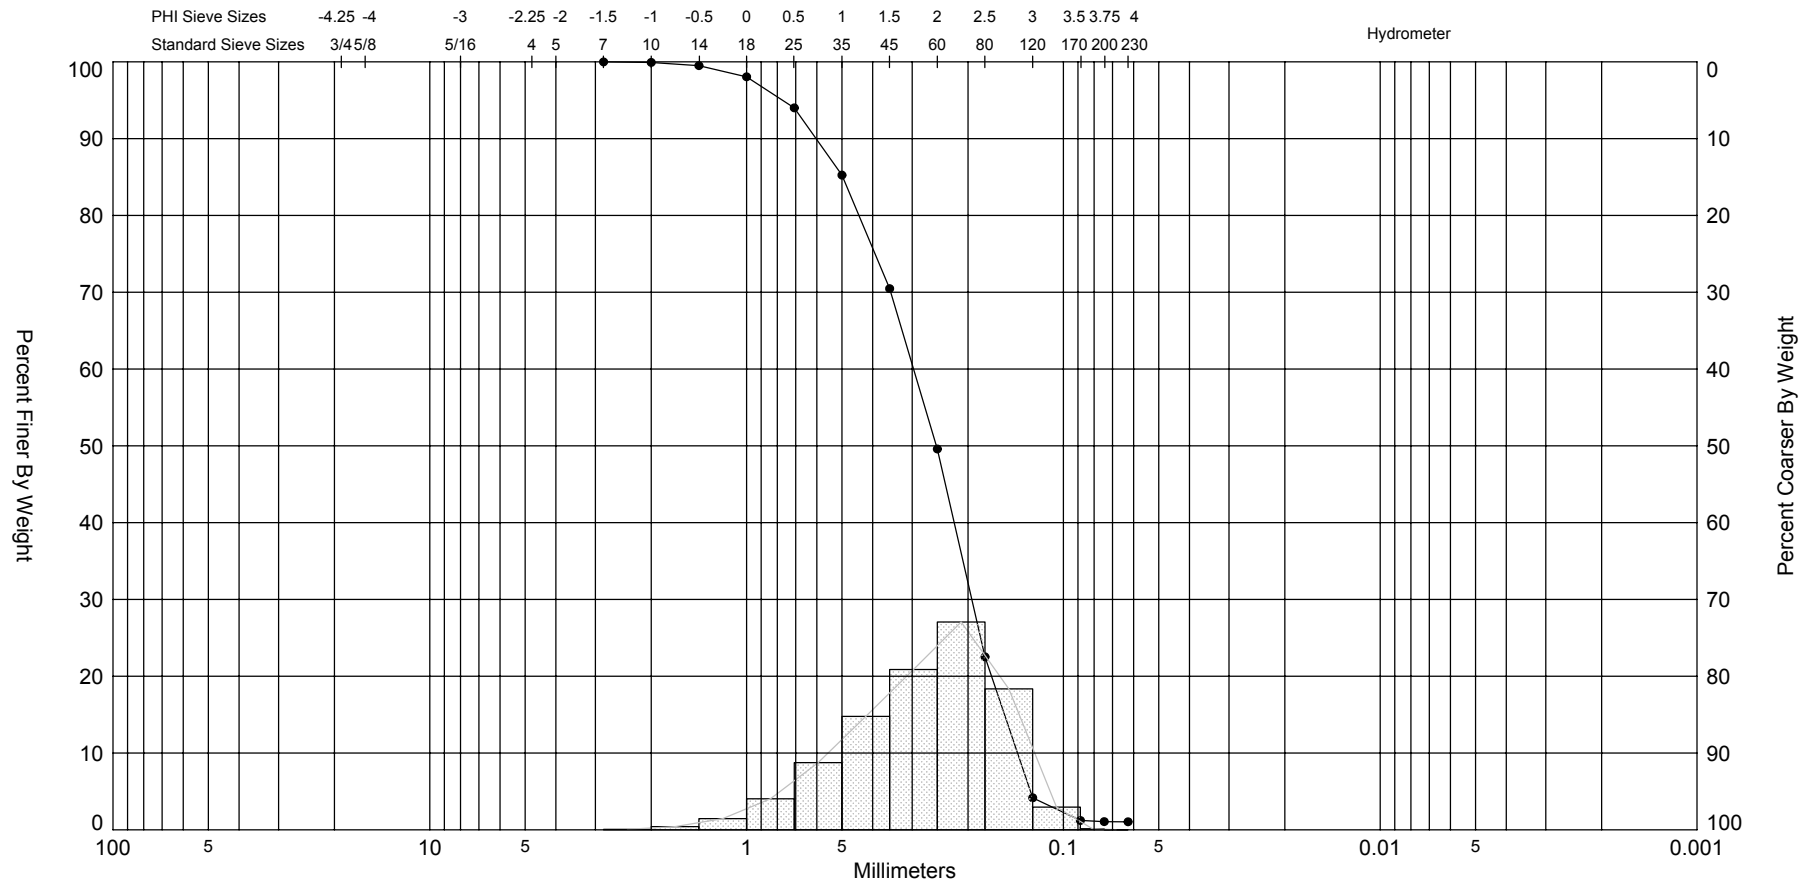
Gravel		Sand			Silt and Clay
Coarse	Fine	Coarse	Medium	Fine

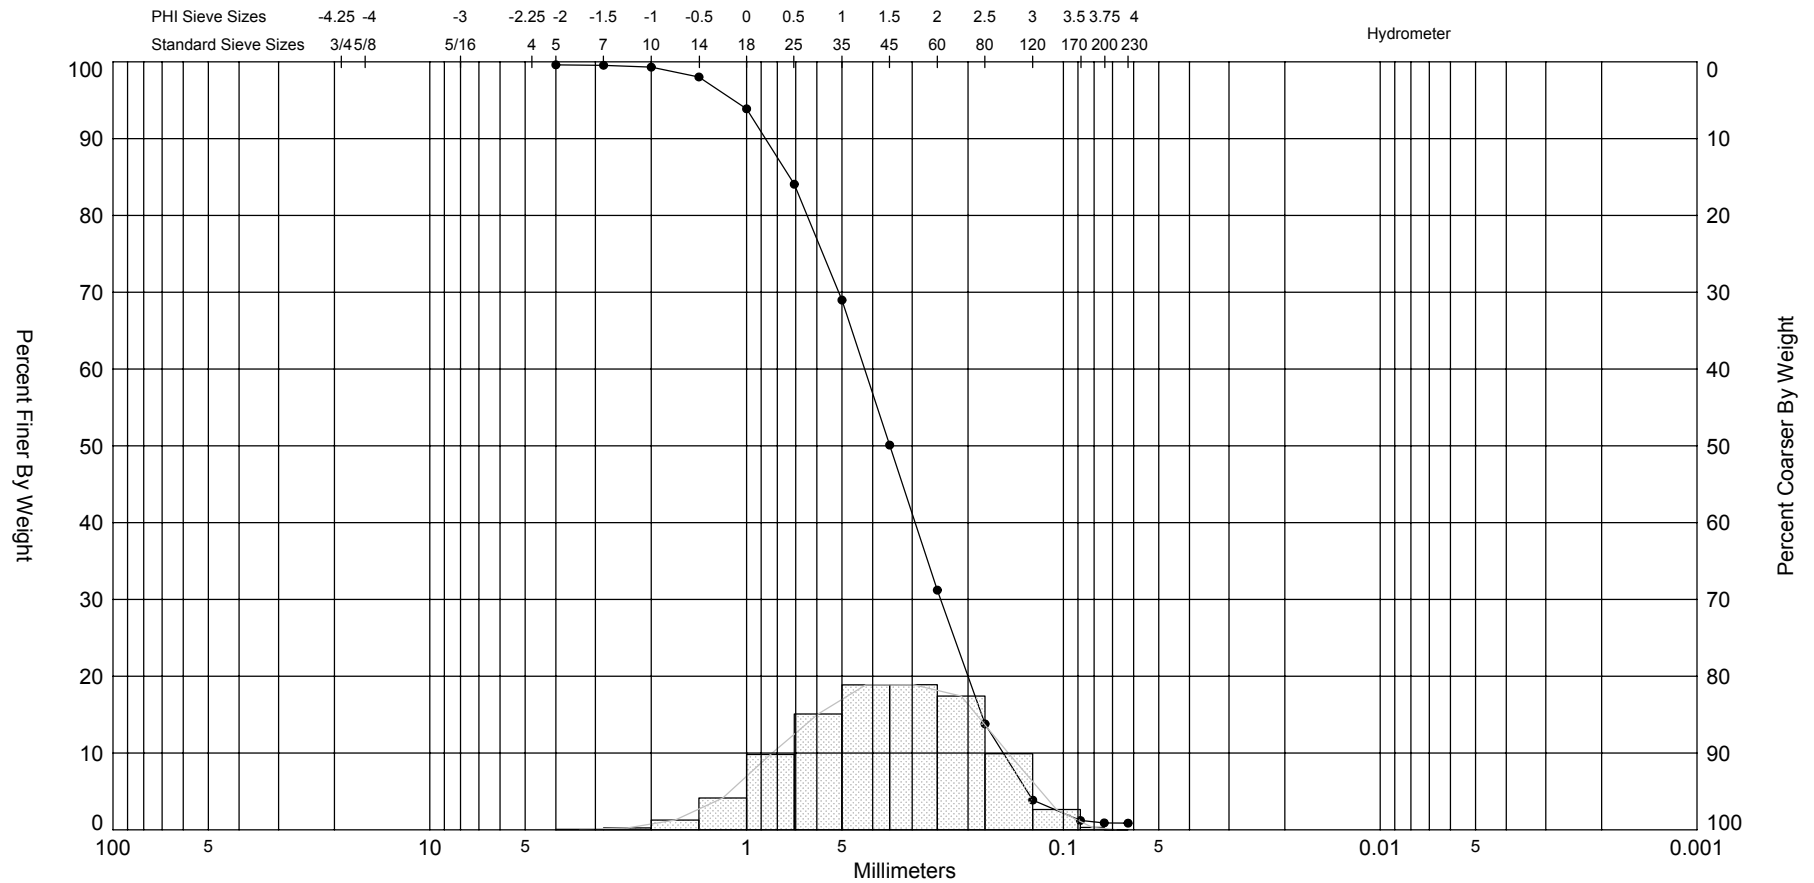
Gravel		Sand			Silt and Clay
Coarse	Fine	Coarse	Medium	Fine

Sample	Symbol	Elev.	Comments	USCS	% Fines	Median	Mean	Skew	Kurt	Sort	Sample Information	
SI04-17 #8.0	—●—	-60.5		SP	#200 - 0.90 #230 - 0.87	1.5	1.46	-0.21	2.6	0.92	Project Name:	Palm Beach County Vibracore 2004
											Analysis Date:	07-01-04
											Analyzed By:	SEA Inc.
Scientific Environmental Applications, Inc. 5575 Willoughby Drive Melbourne, FL 32934 (321) 254-2708 Seapp1@aol.com											Easting (X):	974,944
											Northing (Y):	898,466
											Horizontal System:	NAD 1983
											Vertical System:	NAVD 29
